To: Eric Howes
Moretown Fire Station
1049 Route 100B
Moretown, VT 05660
howes5gdm@yahoo.com

Date: 08/16/10

ENERGY AUDIT REPORT – Moretown Fire Station

Date: 07/19/10

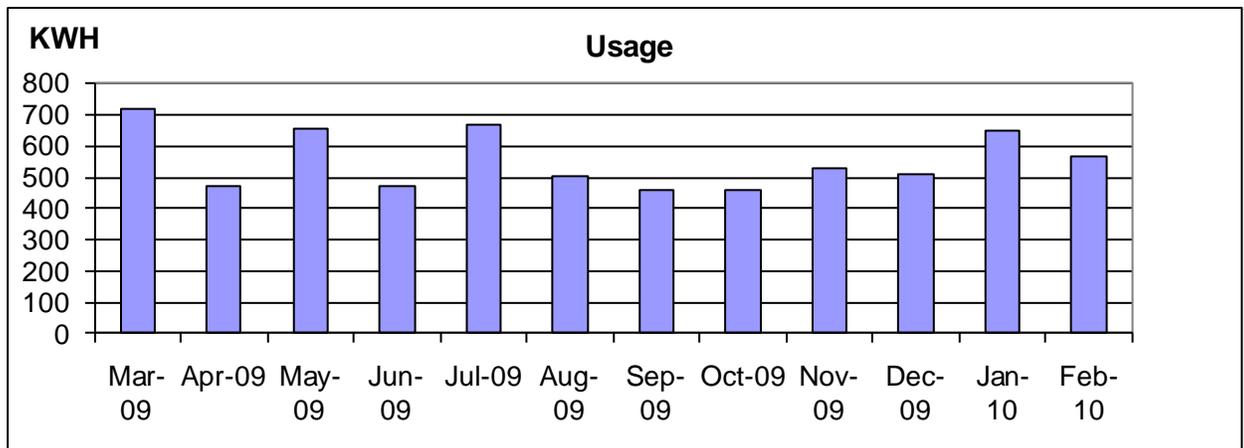
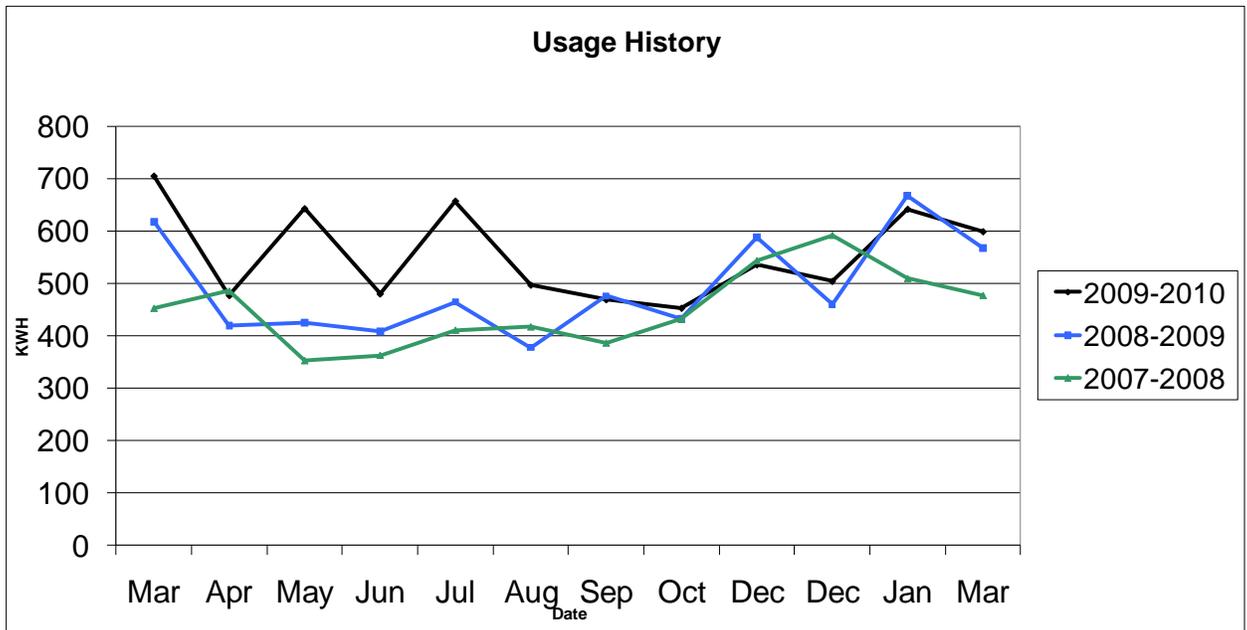
The specialty hose drying equipment and maintaining charge levels in emergency equipment coupled with unpredictable hours of use for this type of building may form a substantial portion of the usage. Higher usage in winter could be attributed to fewer daylight hours, constant need of heating circulation equipment, heating hot water to wash equipment, and a greater need to thaw and dry hoses. There was unusually high usage during the spring and summer of 2009. Refer to the charts below:

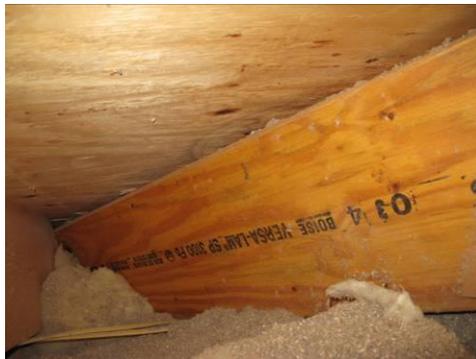
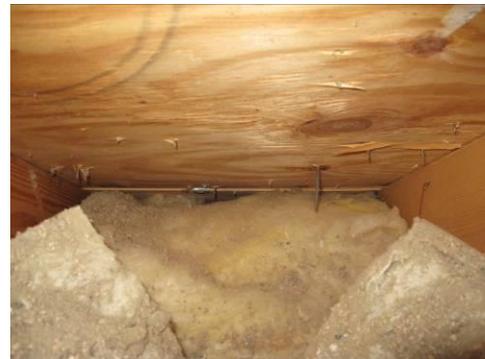
The photos above show the use of fiberglass batts stuffed into the rafter cavity at the top of the exterior eave walls as a blockage to prevent the cellulose insulation from migrating into the soffits. However, this results in an air bypass around the cellulose insulation. The fiberglass insulation also does not prevent wind wash from pushing cold air between the cellulose insulation and sheetrock ceiling. A remedy is to remove the soffits and replace the fiberglass batts with a spray foam barrier that provides a seal to the top of the eave wall, stops wind washing, and provides superior thermal performance.

2. Eave Wall Sealing and Wind Wash Blocking: The object is to seal the top of the eave walls, provide superior insulating value in an area that is typically difficult to attain needed R-value with other types of insulation, and to prevent wind washing under the cellulose insulation.

- Remove soffit and fiberglass batt blocking.
- Clean away cellulose from the edge.
- Spray a foam block to seal top of wall, insulate and provide a dam that prevents wind blocking and cellulose migration into the soffit.

+/-100 square feet. Budget \$45 per square foot. Budget \$4,500.

Save +/- 4% of heat costs.

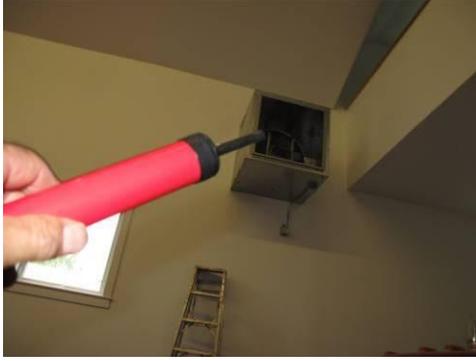
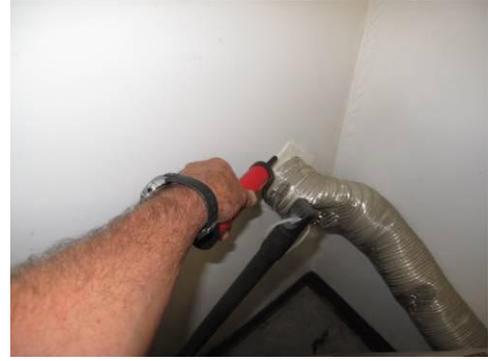
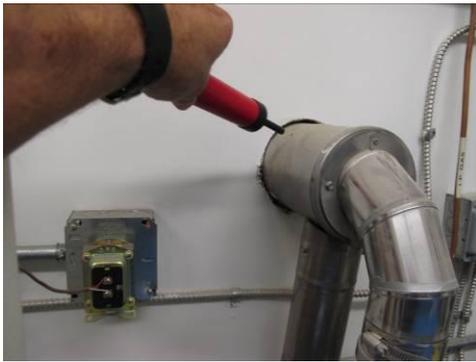
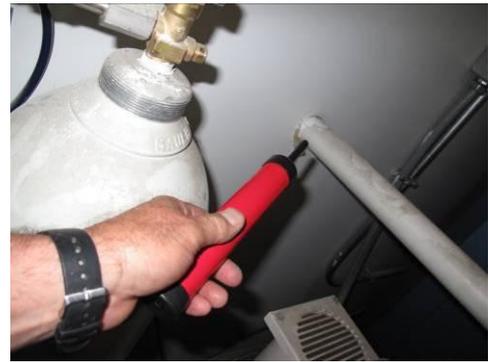
The four photos above show some of the ways that air can leak directly in or out of the building. Cold air will enter near the bottom of the building to make up for warm air that is escaping through leaks into the attic.

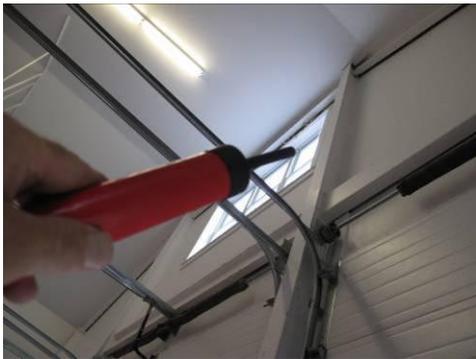
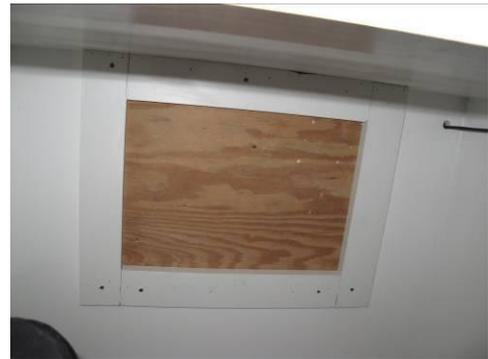
The two photos above show two obvious leaks through the attic plane. On the right, the under insulated attic hatch is also not weather stripped. On the left, the sheetrock edge disappears unsealed behind a beam. It is apparent that air moves through the resulting hidden gap.

- Build and install an R-30 weather stripped attic hatch.
- Seal gaps between structural steel beams and sheetrock with expanding foam sealant.
- Caulk around window, door and corner trim with high quality urethane caulk.
- Seal penetrations through walls and attic plane.
- Seal the mud sill to the top of foundation wall on the exterior.

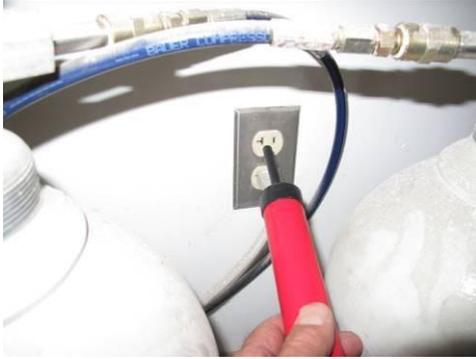
Air moves through these outlets which have no direct connection to the outside. This demonstrates that air moves freely through the unsealed fiberglass, which allows cold air to enter and warm air to escape to the attic.

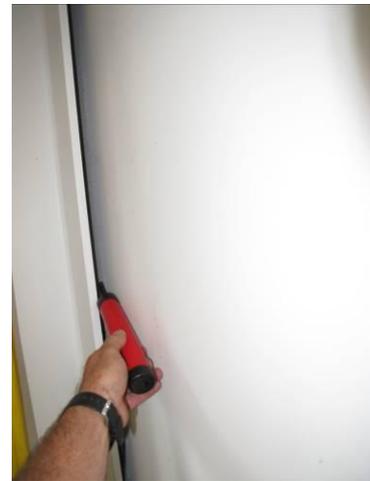
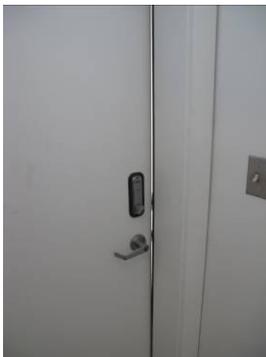
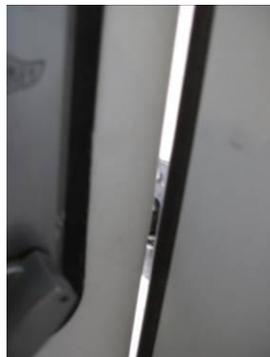
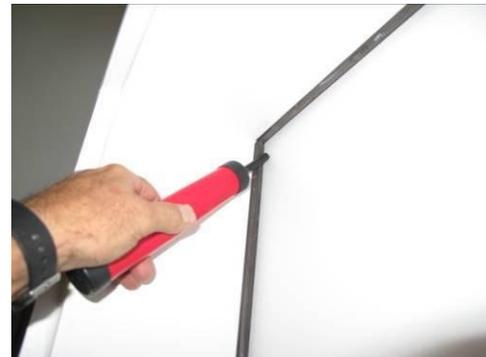
Two out of three entry doors are badly out of adjustment. The photos on the left show the gap and the daylight that is visible on a fully closed and latched door located at the center of the building. The door to the right which is located near the front of the building is also out of adjustment. The doors need to be adjusted to fit the jambs and weather stripping evenly. Strike plates need to be adjusted so that the door is pulled into the weather stripping when closed and latched. In this case, at least one door may need to be taken out and completely re-installed.

3. Entry Door Adjustment:

The object is to adjust the doors to meet the jambs and sill squarely. Close open gaps between door and weather stripping.

- Remove 2 door assemblies and re-install.

- Adjust strike plate
- Replace weather stripping as needed

Budget \$250 per door. Budget \$500
Save +/- 1% of heat costs.

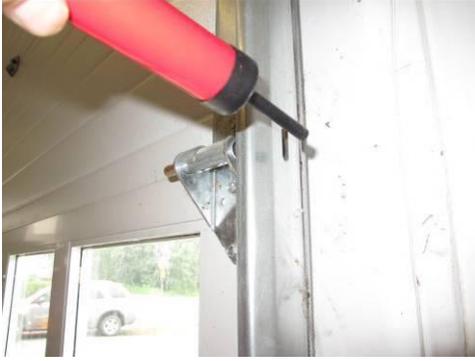
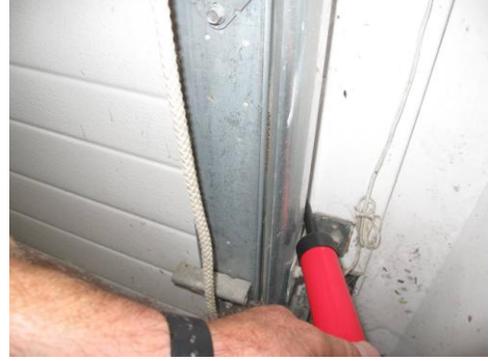
The garage doors have adjustable rollers that can be used to pull the door tighter to the weather stripping or if needed the weather stripping can be installed to meet the doors. In this case it appears that the installation is adequate until there is wind pressure on the doors. With wind on the doors, there is a gap of ¼ inch or more. Weather stripping should be inspected annually and repaired or replaced as needed.

4. Garage Door Adjustment:

The object is to adjust guide rollers to hold the doors tight against the weather stripping while allowing the doors to operate smoothly.

- Adjust rollers.
- Adjust or replace weather stripping as needed.

Budget \$150 per door, Budget \$450
Save +/- 2% of heat costs.

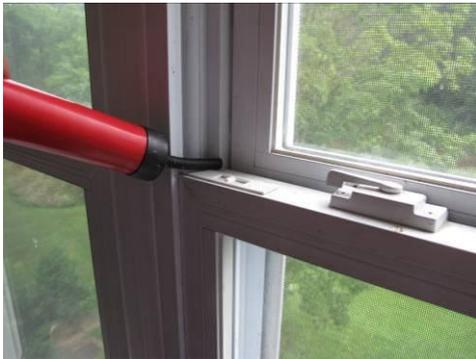
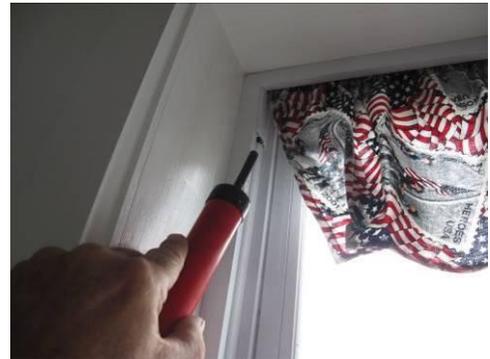
Even newer windows leak at meeting rails and jamb liners. Removable storm panels can be installed in the winter to seal the leaks.

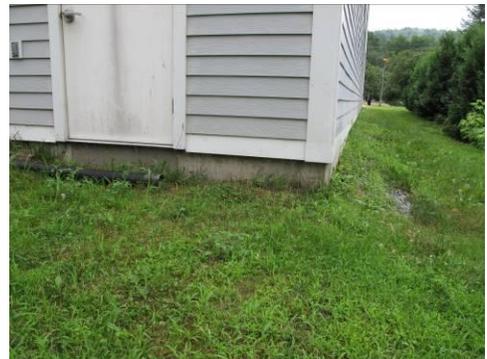
The photo shows the uninsulated slab edge. Perhaps there is a thermal detail on the inside of the slab edge. If not, the uninsulated edge is a heat loss factor.

1. *Foundation insulation:

The objective is to prevent the cold edge of the slab from robbing heat from the radiant heating system. There is no mention of a thermal barrier under or around the slab in the blue prints and specifications that were available for review. Common practice for insulation in radiant slabs would have visible foam board around the perimeter of the foundation as well as a foam board barrier beneath the slab. It may be possible that the slab was insulated from beneath with no provision for the cold edge. If this is the case, installation of foam around the perimeter of the building should be undertaken.

- Dig a shallow ditch around the entire building, excluding the paved driveway, to access the foundation wall and slab for foam insulation.
- Pressure wash the concrete for better adhesion of glue
- Install 2" of foam board R-10 to 1.5' below grade.
- Parge foam with fiberglass reinforced coating or flash to below grade.
- Backfill ditch, rake, seed, and mulch.
- Install formed flashing under siding to cover step in foundation profile and prevent moisture intrusion.

Budget \$50 per foot. Budget \$8,500

Save +/-6% of heating costs if the slab edge is currently un-insulated.
