TA22(11)

May 6, 2024

**MORETOWN  
SHARED USE PATH  
SCOPING STUDY**

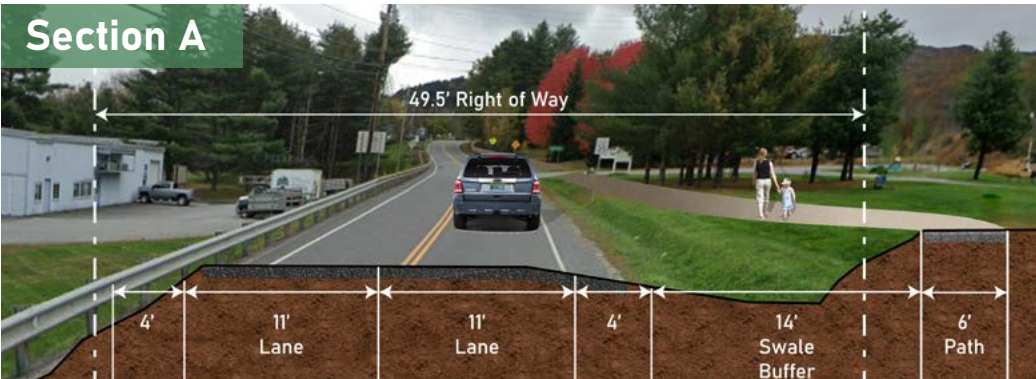
Section view of the western section of the project area.

The preferred design concept adds a six foot wide, paved pedestrian path along the south side of US-2. This gives travelers more space than a traditional five foot sidewalk but is less costly than a full 10' shared use path. The path is separated from the road by a curb and three foot vegetated buffer. The exception is in front of Aubuchon Hardware, where the path has been moved further from the road to accommodate the existing swale. This buffer offers an added layer of distance from the road, and avoids the construction challenge of moving or replacing the existing swale. Finally, three crosswalks have been added to the area, one each across VT-100, Mason Drive, and Fairground Road.

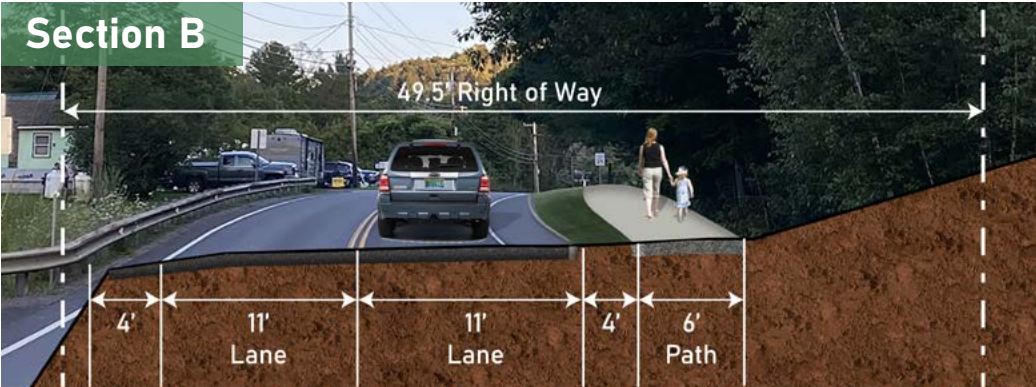
Section view of the central section of the project area.

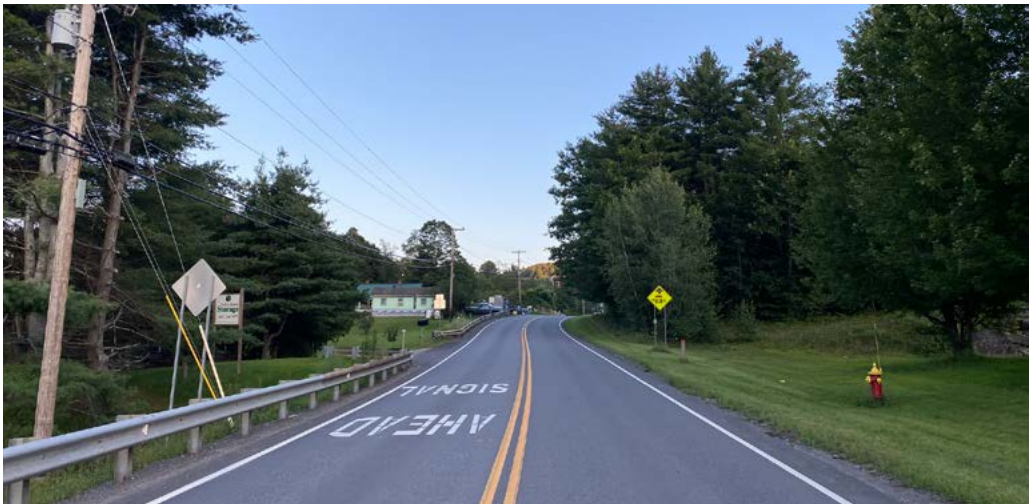
Eastward view of US-2 in the project area. The straight road provides good sight-lines for drivers.

This section of US-2 is relatively straight, and sight-lines are clear. However, there are no streetlights, so vision from vehicles to the road shoulder is limited in low-light conditions.

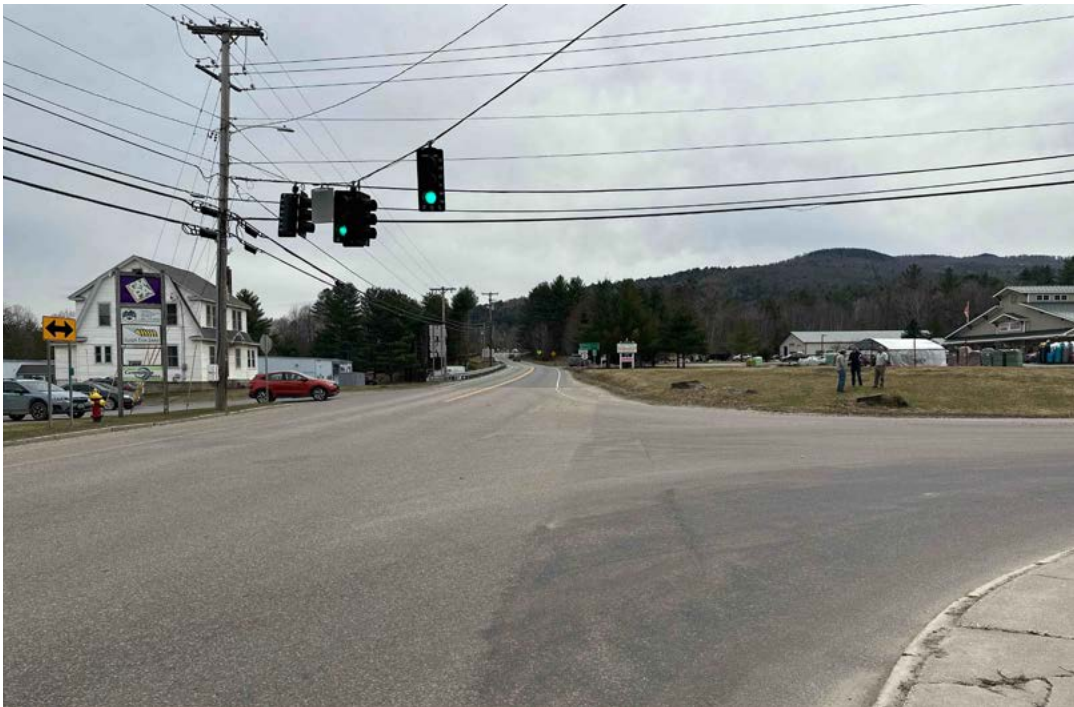
A view southeast into the project area showing the intersection of US-2 and VT-100. Note the existing sidewalk (bottom right) and its lack of crossing connections through the intersection.

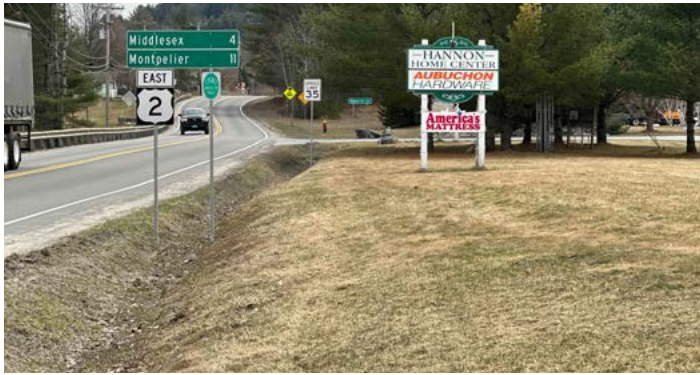
The swale on the south side of US-2, in front of the Aubuchon Hardware

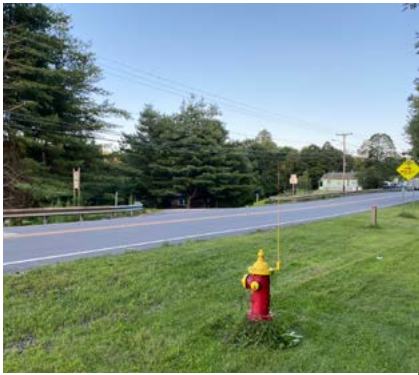
A fire hydrant on the south side of US-2

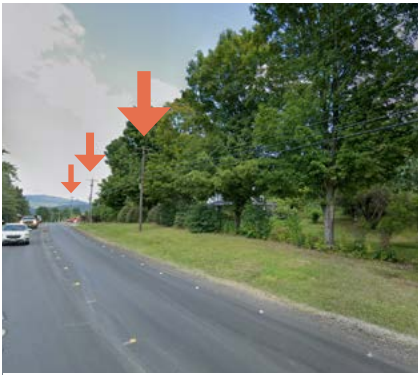
The line of telephone poles following the north side of US-2

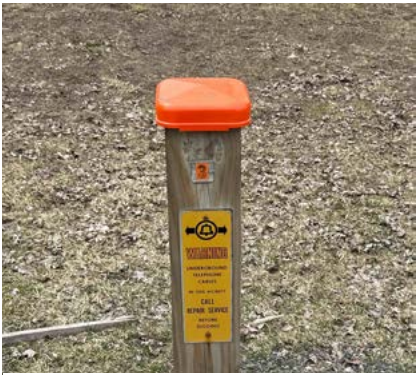
A marker indicating the presence of buried telephone lines nearby

Site analysis revealed a sign indicating there are buried telephone cables on the south side of the road (pictured right). However, desktop analysis using data from the Vermont Center for Geographic Information (VCGI) did not contain records of buried telephone lines in this location.

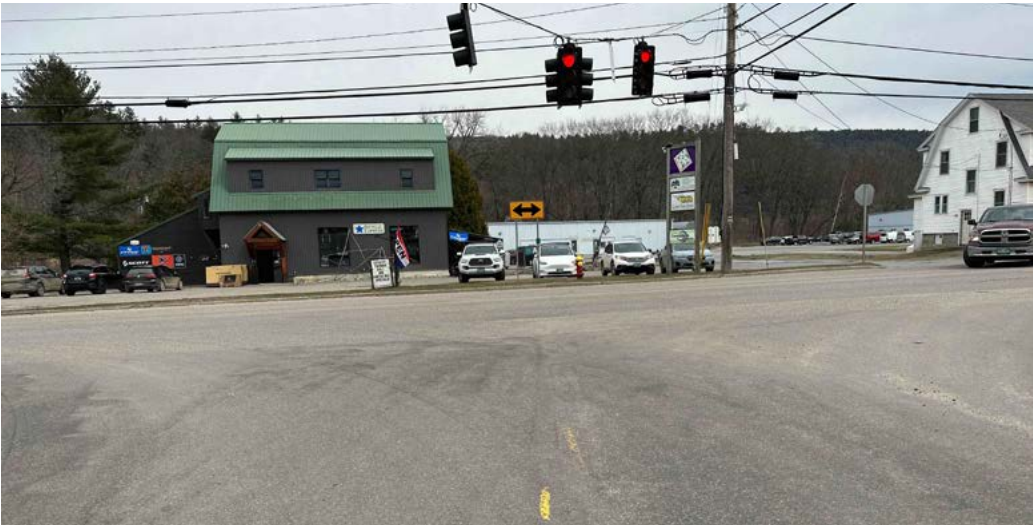
*Without a crosswalk, pedestrians are left with a “free for all” when crossing the wide intersection of US-2 and VT-100*

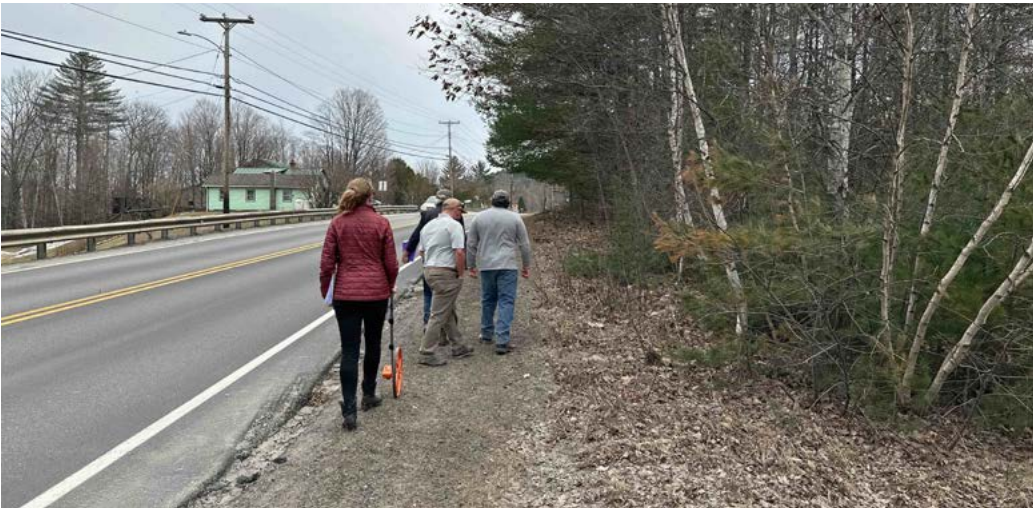
*Pinch points caused by trees and other obstacles – as pictured here – will continue to provide potentially hazardous walking conditions*

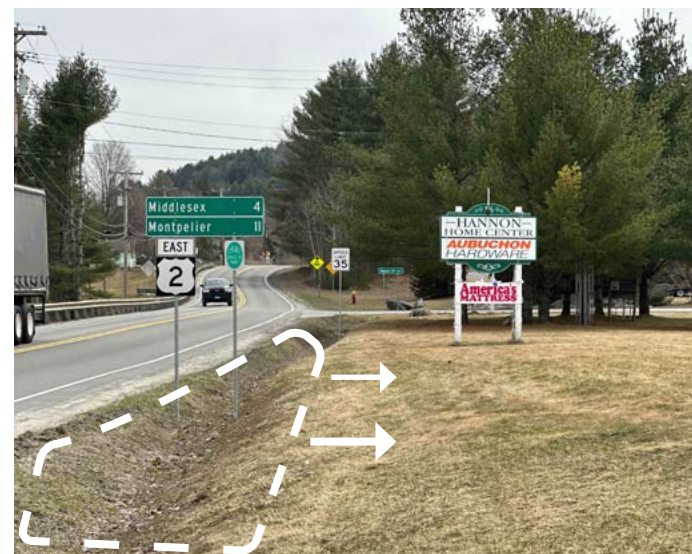
*The swale in front of Aubuchon Hardware will have to be moved, potentially crossing property lines.*

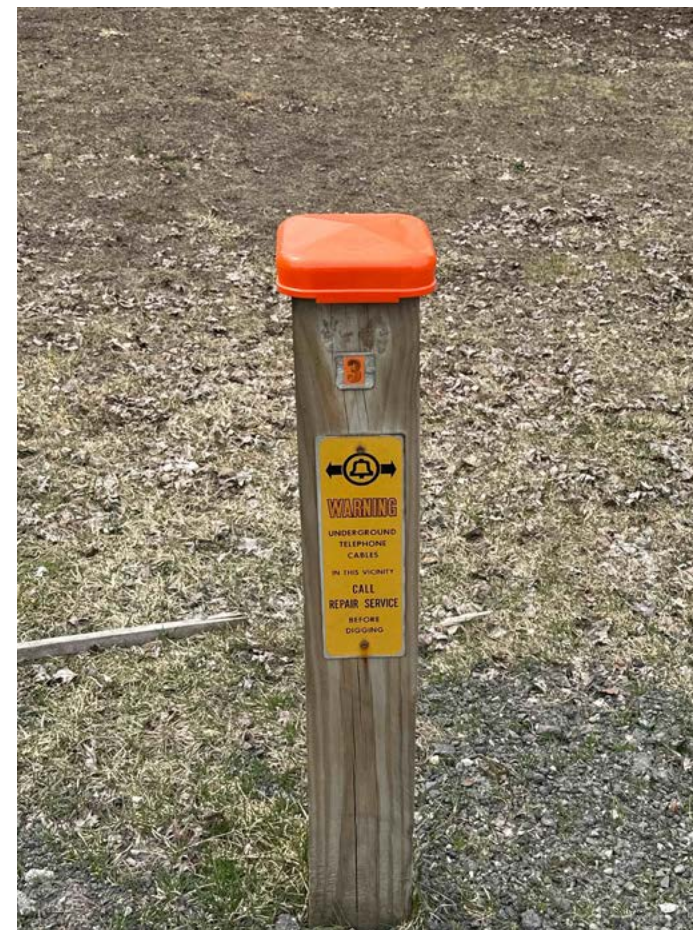
*A buried water pipe and potentially buried phone lines may affect construction.*

Several trees are growing close to the side of the road and will need removal to make way for the sidewalk. Two fences will need to be removed and reset during construction. Survey will be required to accurately locate the buried 8 inch water pipe along the road's edge, plus the potential buried telephone lines.

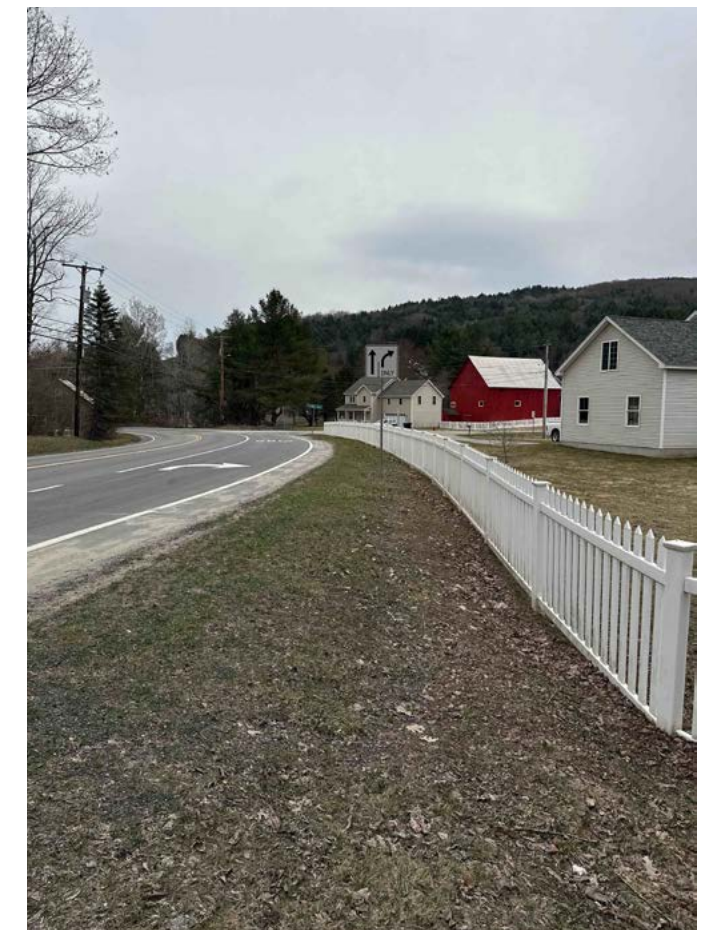
*This fence will have to be removed and reset during construction.*

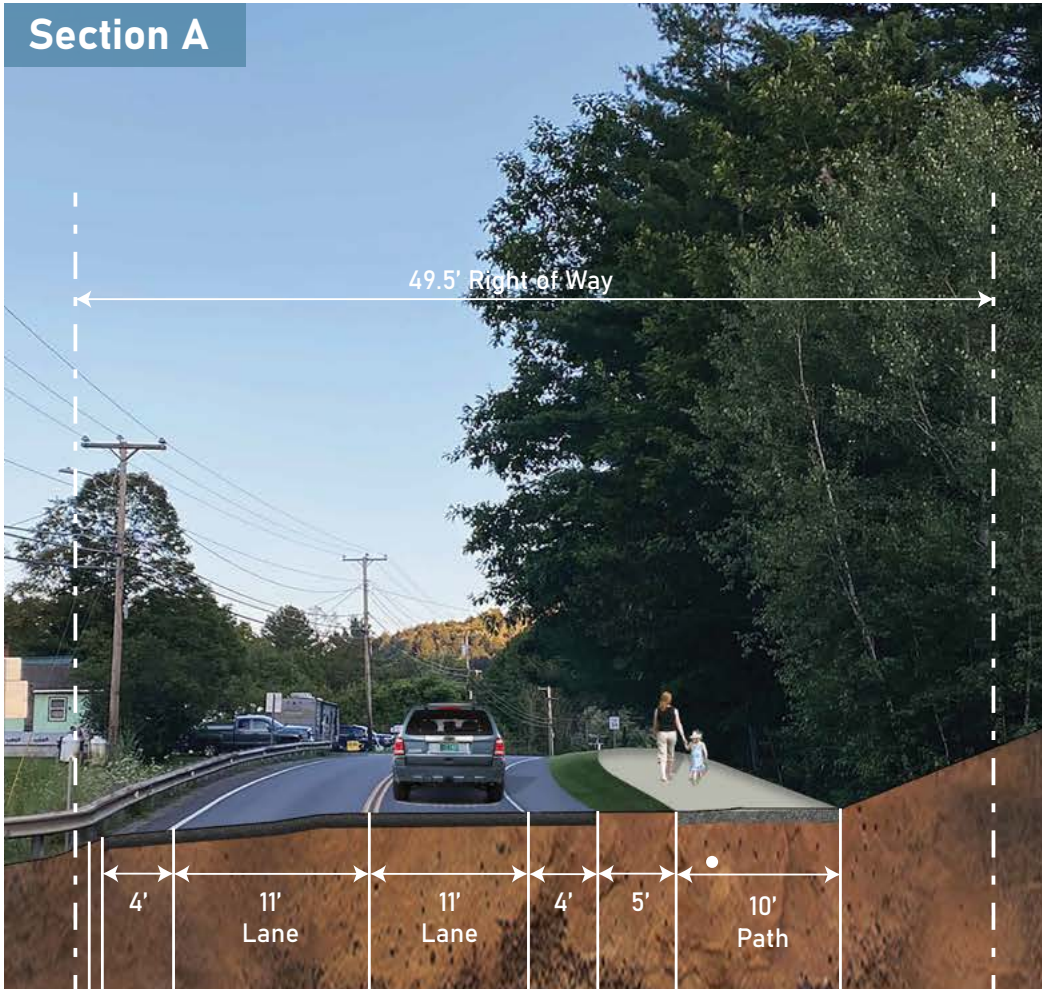
Section view of the western section of the project area.

This design provides an elevated user experience, while addressing community concerns. The ten foot wide path provides ample room for multiple users of various transportation methods, including cyclists and pedestrians. The vegetated setback from the road also provides an added layer of protection for path users, by separating them fully from the vehicles traveling on US-2. Without the green

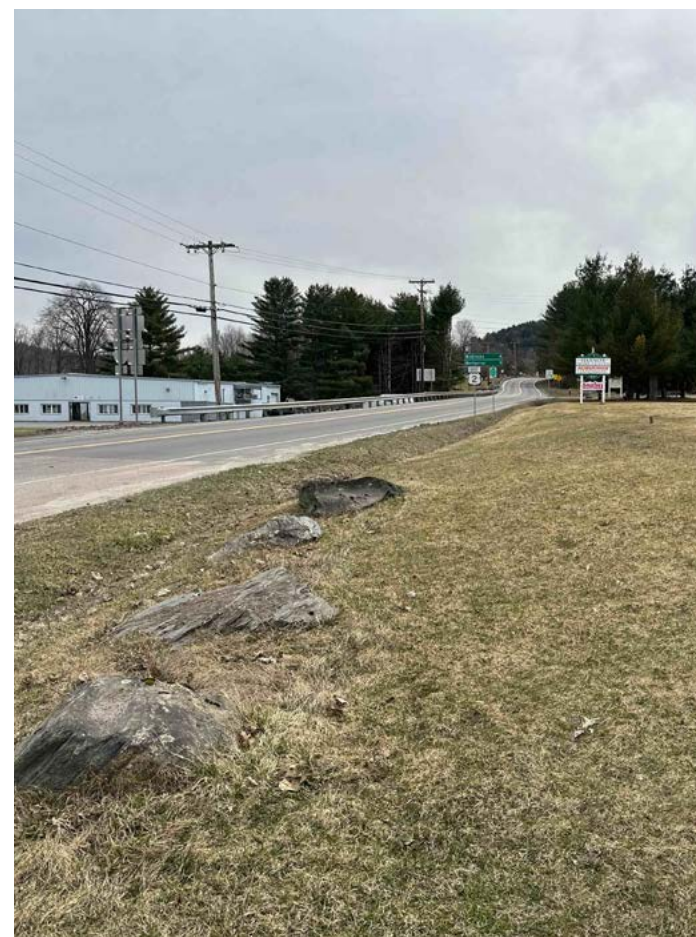
*This swale in front of Aubuchon Hardware is preserved in Concept 2. However, the path itself may cross property lines to make room.*

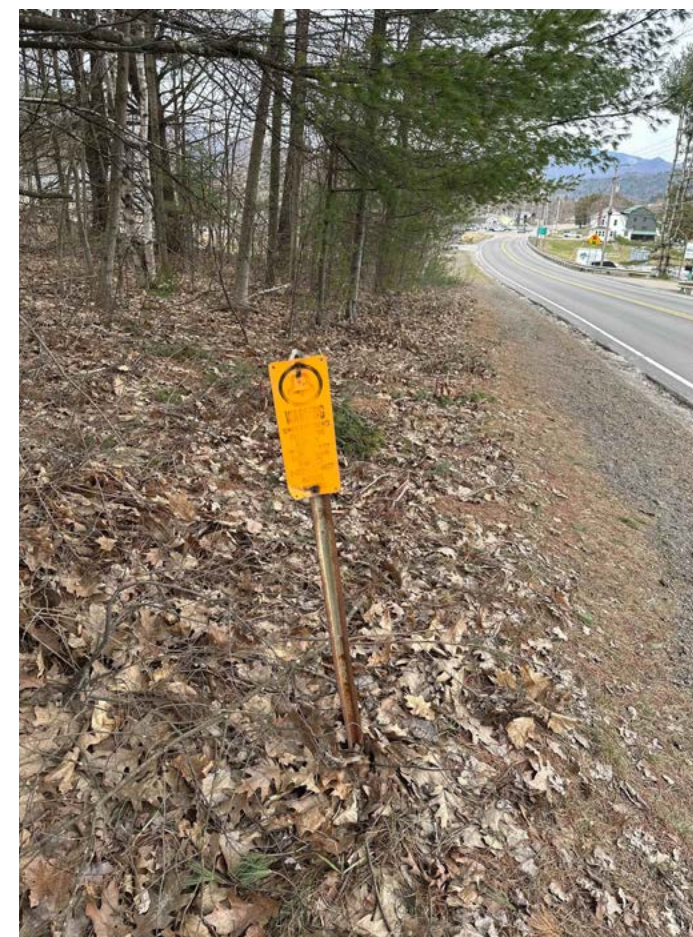
*Trees and steep slope near the road will likely impact the wider path and buffer area.*

Unique to Concept 2 are also potential slope impacts between Mason Drive and Fairground Road. The slope in this location is such that it may require a retaining wall or more extensive grading. Concept 2 is also the most expensive design of all three preliminary designs.

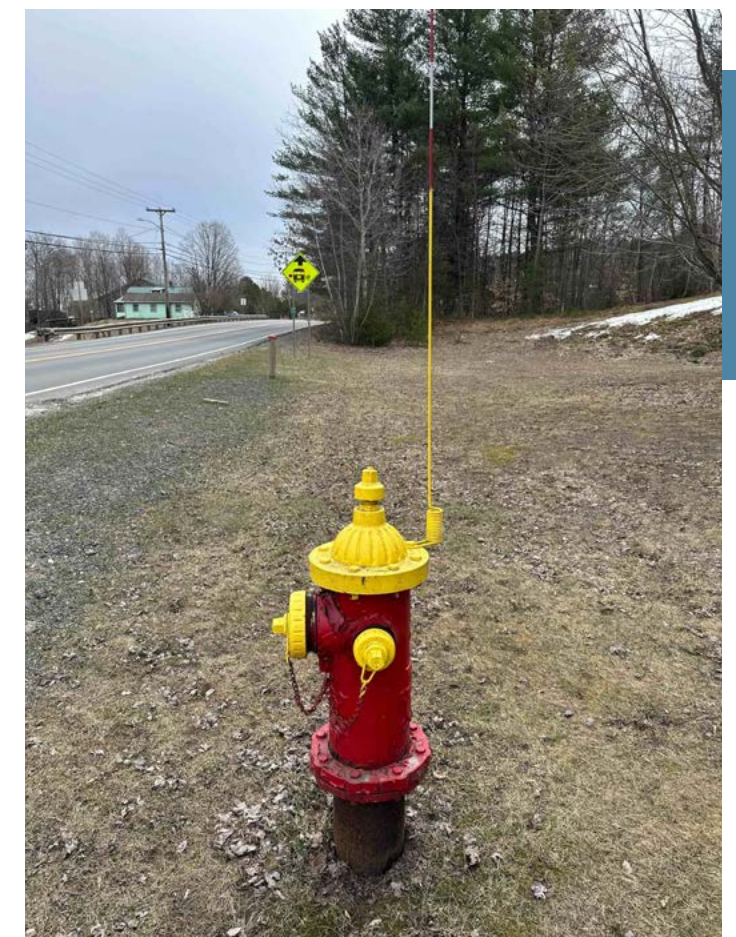
*This hydrant may need to be moved in Concept 2.*

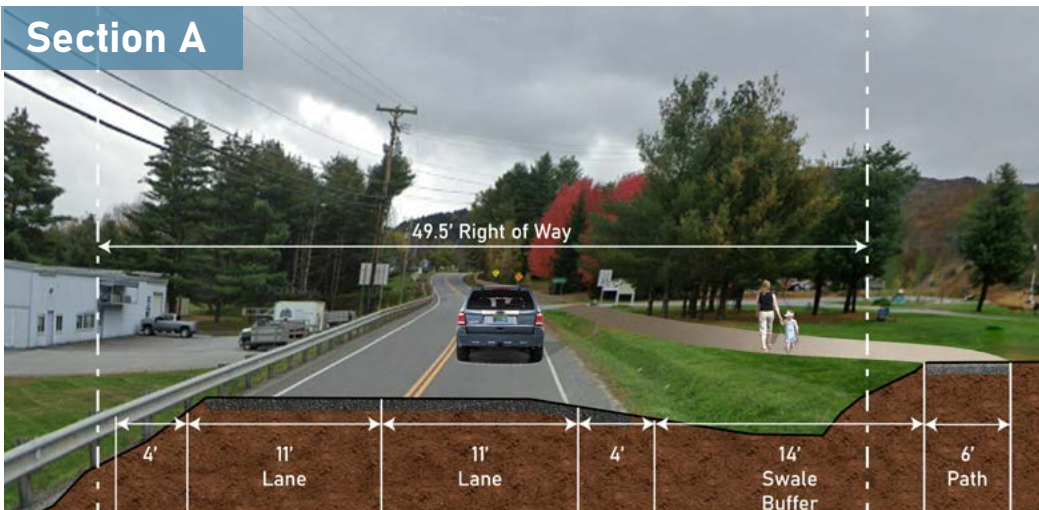
Section view of the western section of the project area.

This design adds a six foot wide, paved pedestrian path along the south side of US-2. This gives travelers more space than Concept 1, but is less costly than Concept 2. The path is separated from the road by a vegetated buffer. The vegetated buffer is three feet wide in most places. The exception is in front of Aubuchon Hardware, where the path has been moved further from the road to accommodate the existing swale. This buffer offers an added layer of distance from the road, as in Concept 2, but avoids the construction challenge of moving or replacing the existing swale. Finally, three crosswalks have been added to the area, one each across VT-100, Mason Drive, and Fairground Road.

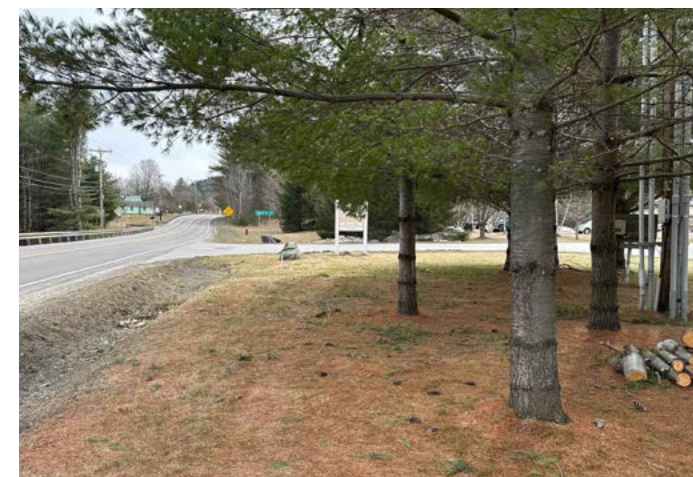
*Trees may need to be removed or roots may be impacted.*

Across from the cemetery is some additional vegetation that may need to be removed, as well as a fence that will need to be removed during construction and reset in place. For the trees that will need to be removed, or that may decline after installation, it is highly suggested that the community replace these trees near where they originally were.

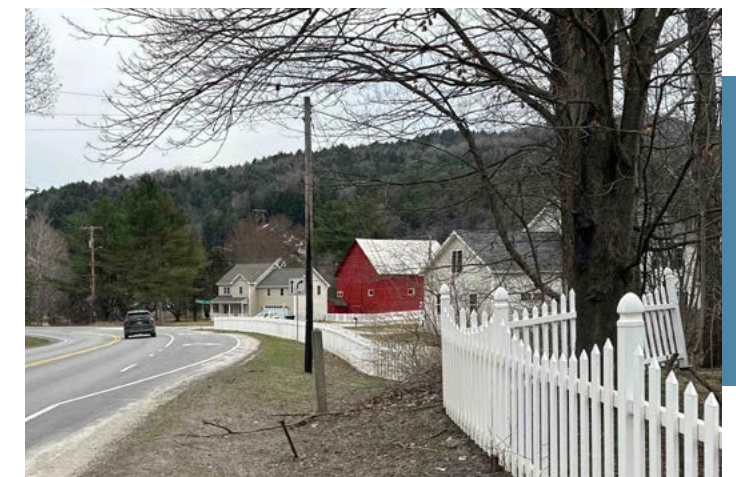
*Fence to be removed and reset; telephone pole to be relocated.  
Tree roots may be impacted.*

during construction and reset in place. Between these two fences is a small grove of trees whose root systems may be impacted as well as a telephone pole that will need to be relocated.

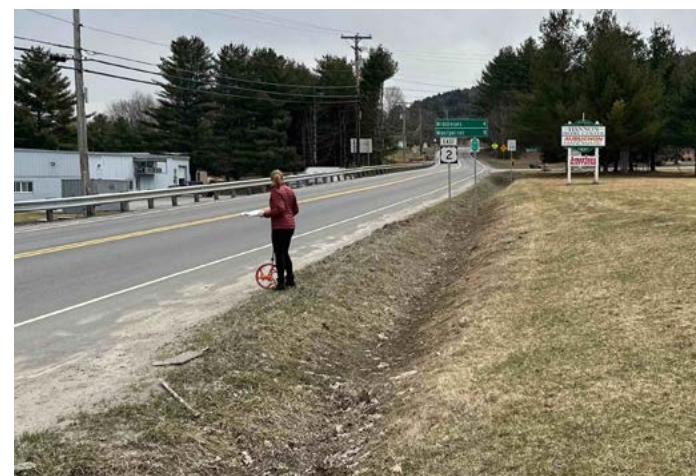
*Existing swale to remain in front of Aubuchon Hardware.*

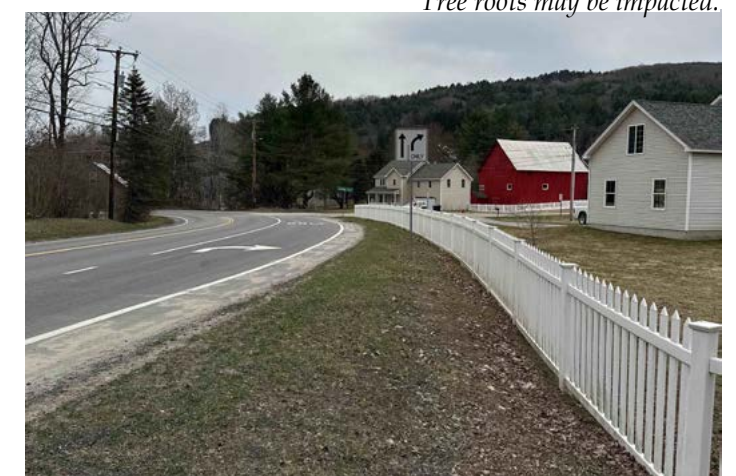
*Fence to be removed and reset.*

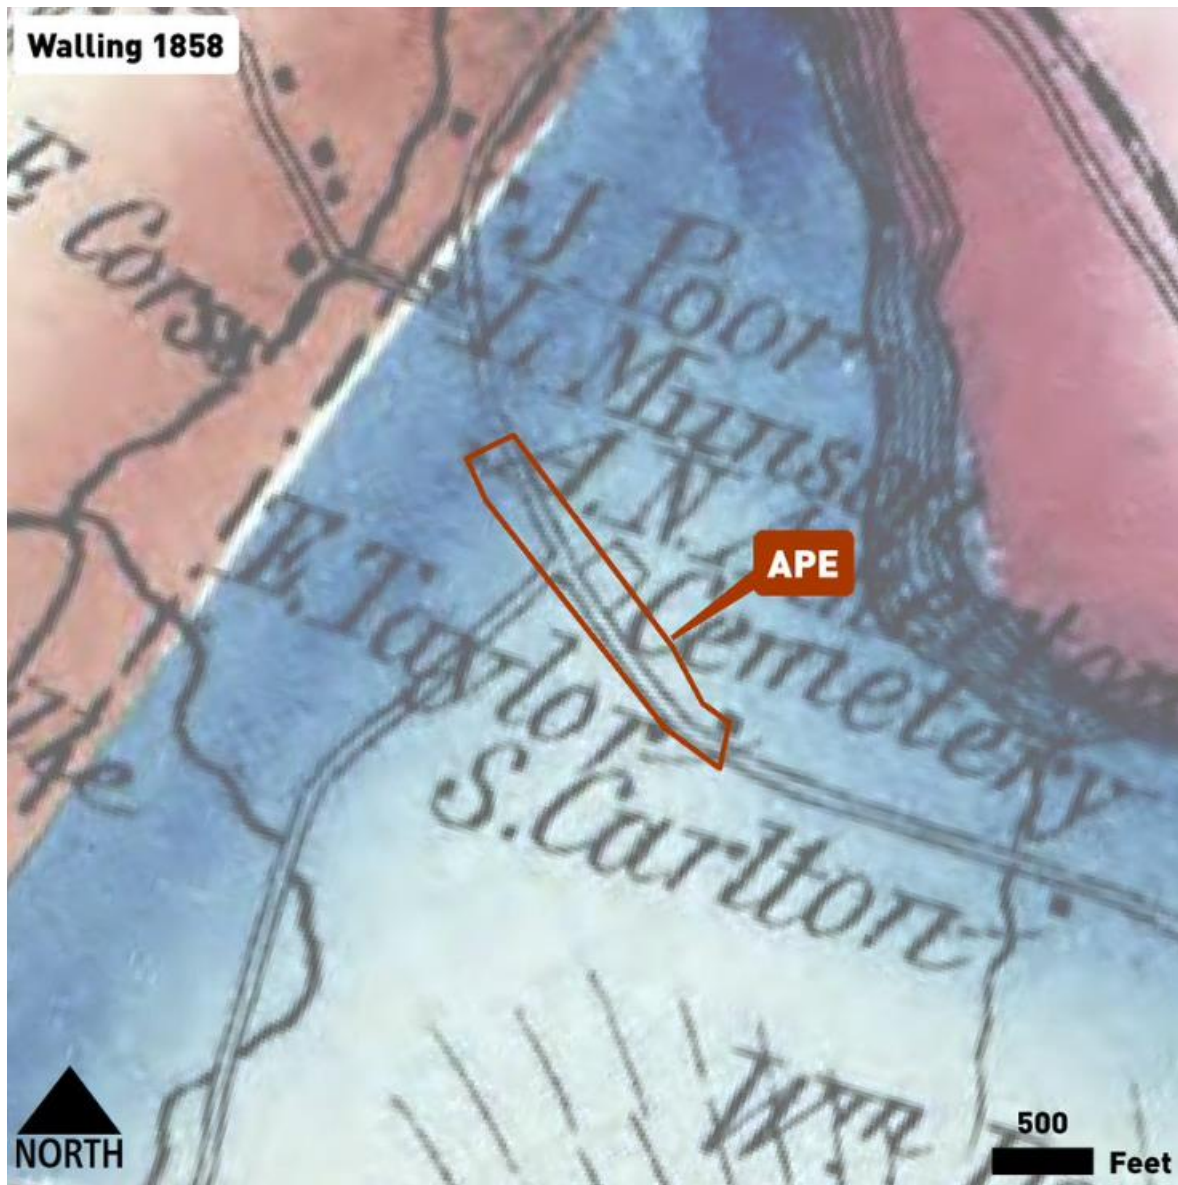
Figure 2. 1858 (Walling 1858).

Despite being one of the first areas settled in Moretown, there was little early industrial activity in North Moretown, and the village was characterized by subsistence farming throughout the 19<sup>th</sup> century. During this period, there were approximately five homesteads in the APE, with the E. Taylor House (Resource 12) being the only surviving farmstead (Figure 2).

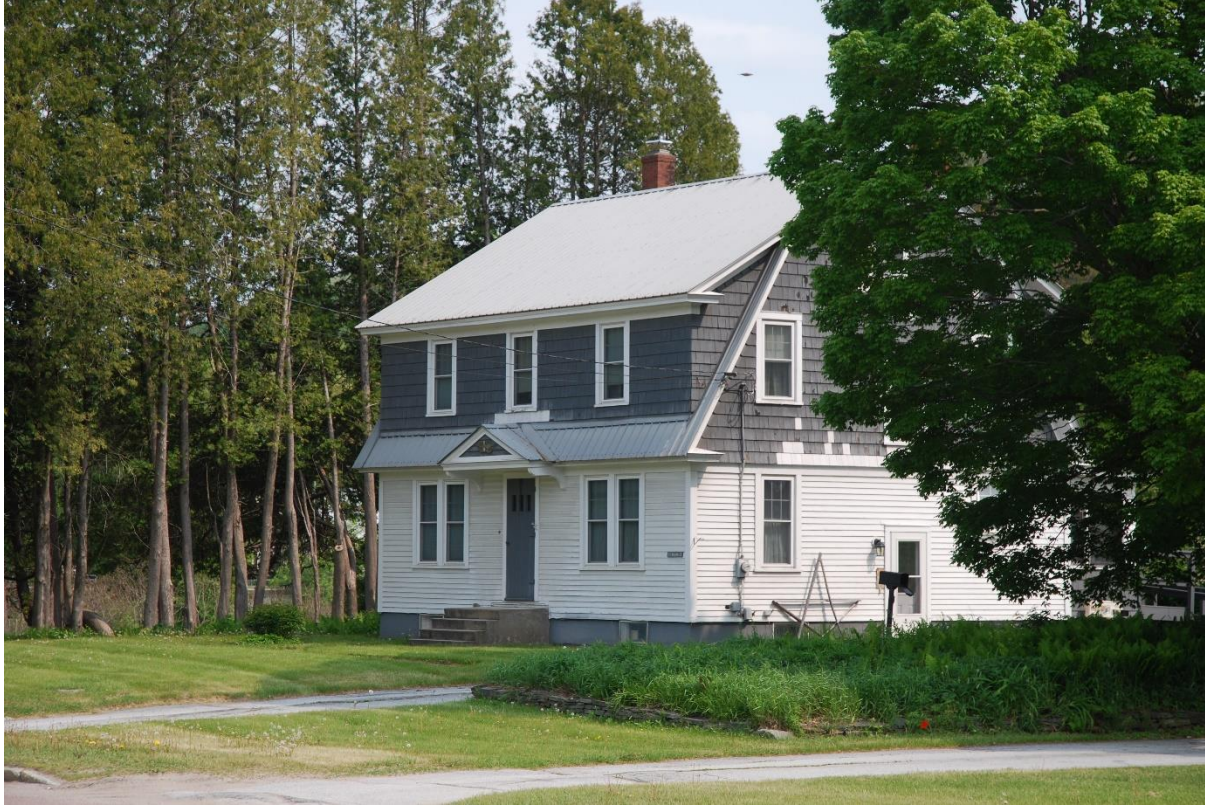
Photo 5. View of Resource 1 at 71 Route 2, looking north.

Resource 1 (Photo 5, Photo 6, and Photo 7) has not been previously surveyed for the potential inclusion in the Vermont State Register or the National Register of Historic Places. Built c.1928, it is a two-story, side-gabled, wood-frame, single-family-dwelling (USGS 1919). Resting on a concrete foundation, it is sheathed with wood clapboards and wood shingles. It has a corrugated metal roof. Fenestration consists of six-over-one replacement double-hung sash. Extending along the street-facing (west) elevation is a full shed-roofed dormer. Centered on the west elevation is the entry protected by a pedimented roof supported by brackets. An interior chimney rises from the south and north ends of the east roofline. A one-and-a-half-story, gable-front, gambrel-roofed, two-bay garage is associated with the house.

The dwelling at 71 Route 2 is eligible for inclusion in the National Register of Historic Places under Criterion C. Distinctive features include a shed-roofed full-width dormer, multiple siding materials, and bracket-supported entrance roof.

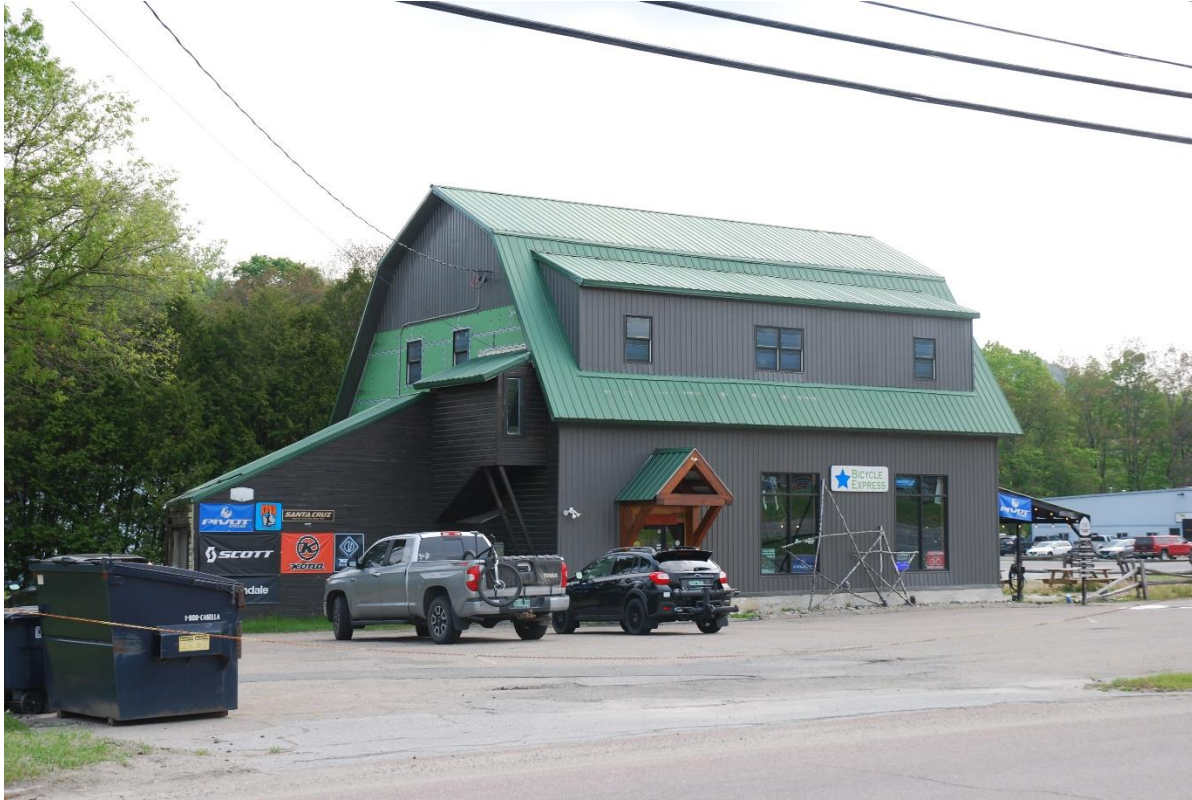
Photo 8. View of Resource 2 at 23 Commercial Drive, looking east.

Resource 2 (Photo 8 and Photo 9) is known as Bicycle Express. It has not been previously surveyed for the potential inclusion in the Vermont State Register or the National Register of Historic Places. Built c.1928, it is a two-story, gambrel-roofed commercial structure (USGS 1919). Resting on a concrete foundation, it is sheathed with metal siding, and it has a corrugated metal roof. Fenestration consists of replacement one-over-one double-hung sash and single-pane casement windows. A shed dormer extends along the entirety of the street-facing (west) elevation. A one-story, shed-roofed addition abuts the north gable end. The street-facing (west) elevation has two large, fixed glass storefront windows and a replacement glass entry door protected by a pedimented porch.

Bicycle Express is not eligible for inclusion in the National Register of Historic Places due to loss of integrity resulting from alterations in the form of replacement siding, replacement windows, and changes in the fenestration pattern.

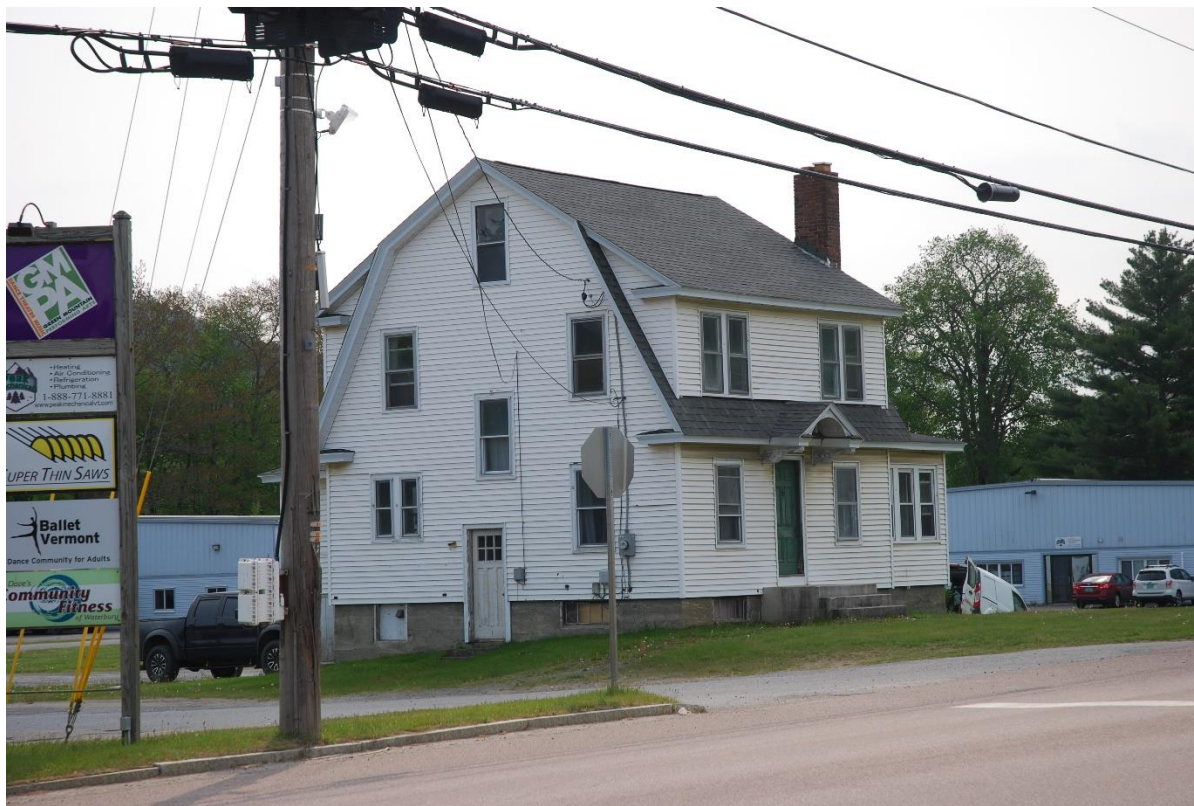
Photo 10. View of Resource 3 at 16 Commercial Drive, looking southeast.

Resource 3 (Photo 10 and Photo 11) has not been previously surveyed for the potential inclusion in the Vermont State Register or the National Register of Historic Places. Built c.1928, it is a two-story, side-gabled, wood-frame, gambrel-roofed, single-family-dwelling (USGS 1919). Resting on a concrete foundation, it is sheathed with vinyl siding, and it has an asphalt shingle roof. Fenestration consists of one-over-one replacement double-hung sash. A full wall dormer with cornice returns extends along the east and west elevations. Centered on the west elevation is the entry protected by a pedimented roof supported by brackets. A brick chimney abuts the south gable end. A one-story, hip-roofed enclosed porch abuts the south gable end.

The building at 16 Commercial Drive is not eligible for inclusion in the National Register of Historic Places due to loss of integrity resulting from alterations in the form of replacement siding and windows.

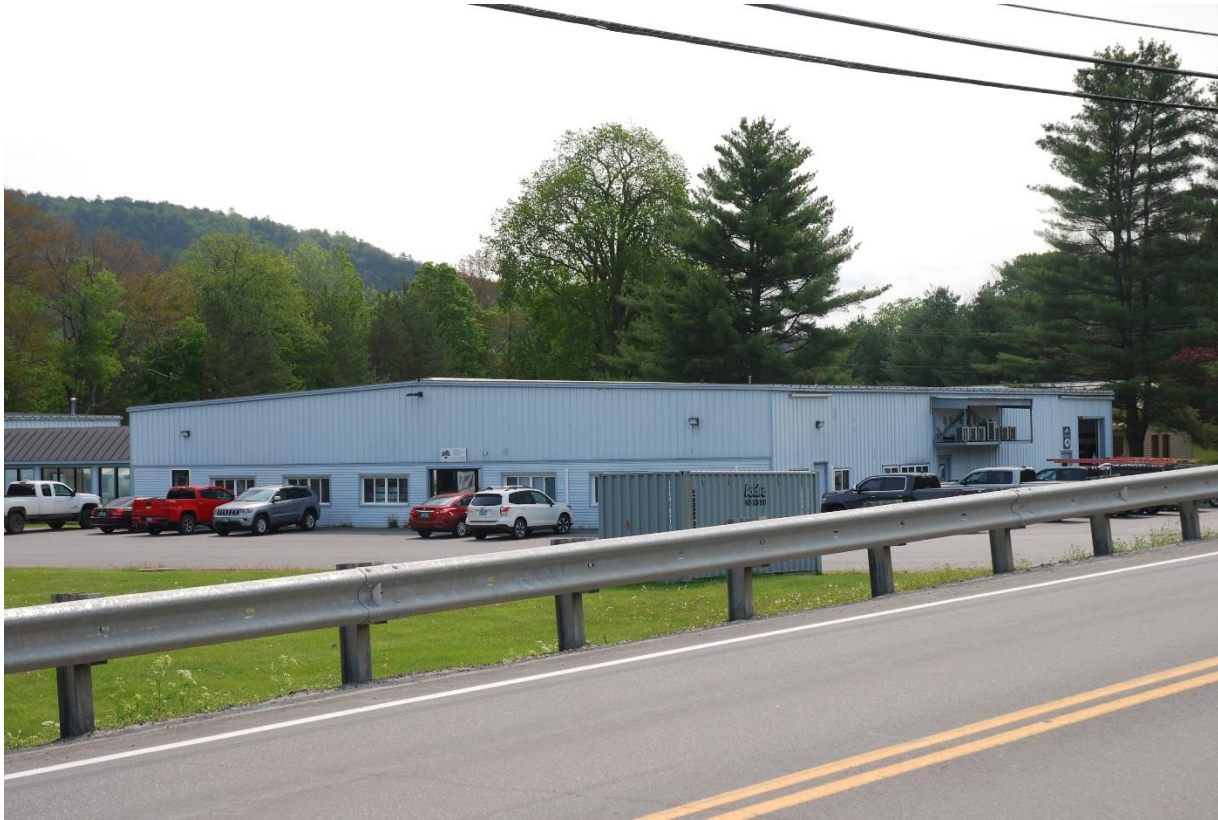
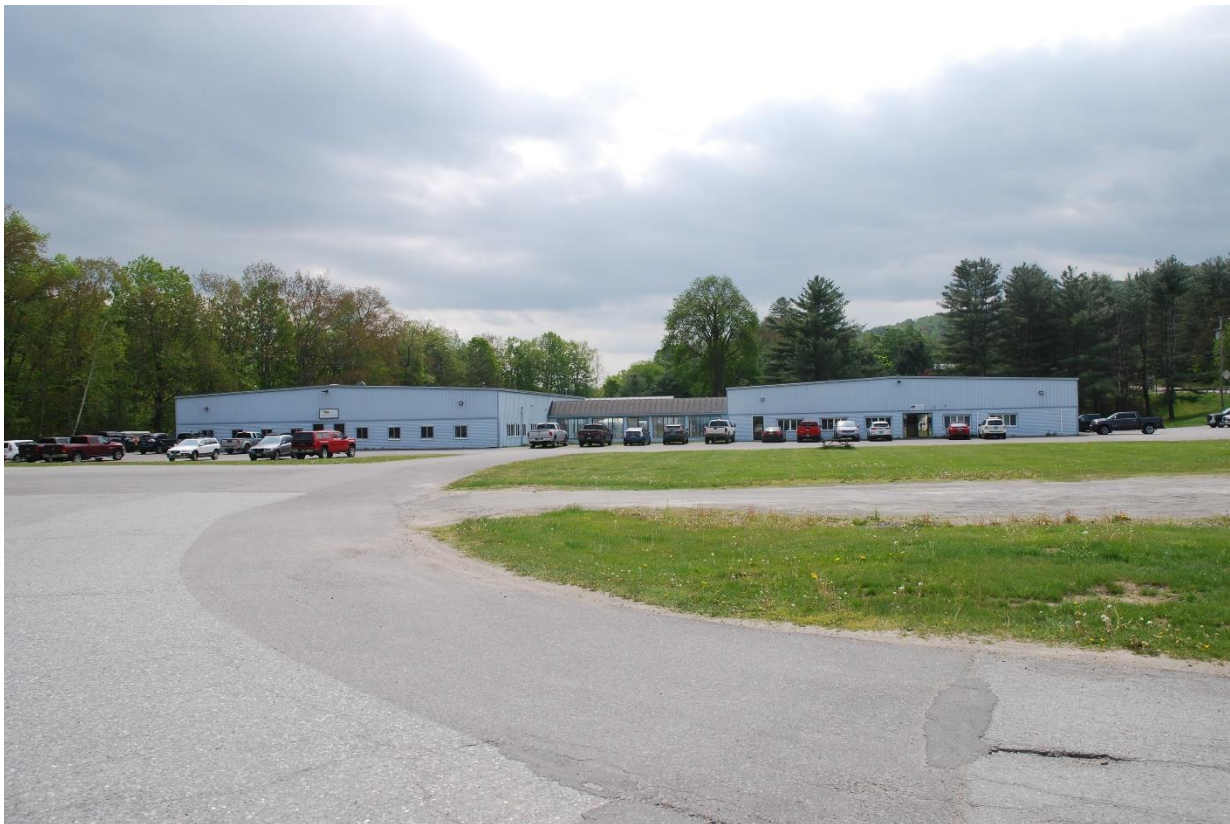
Photo 12. View of Resource 4 at 80 Commercial Drive, looking east.

Photo 13. View of Resource 4 at 80 Commercial Drive, looking southeast.

Resource 4 (Photo 12 and Photo 13) is known as the Super Thin Saws building. It has not been previously surveyed for the potential inclusion in the Vermont State Register or the National Register of Historic Places. Built c.1990, the resource consists of two large, one-story manufacturing facilities and a one-story connector. The buildings are sheathed with metal siding and have membrane roofs. Fenestration consists of single-pane casement windows.

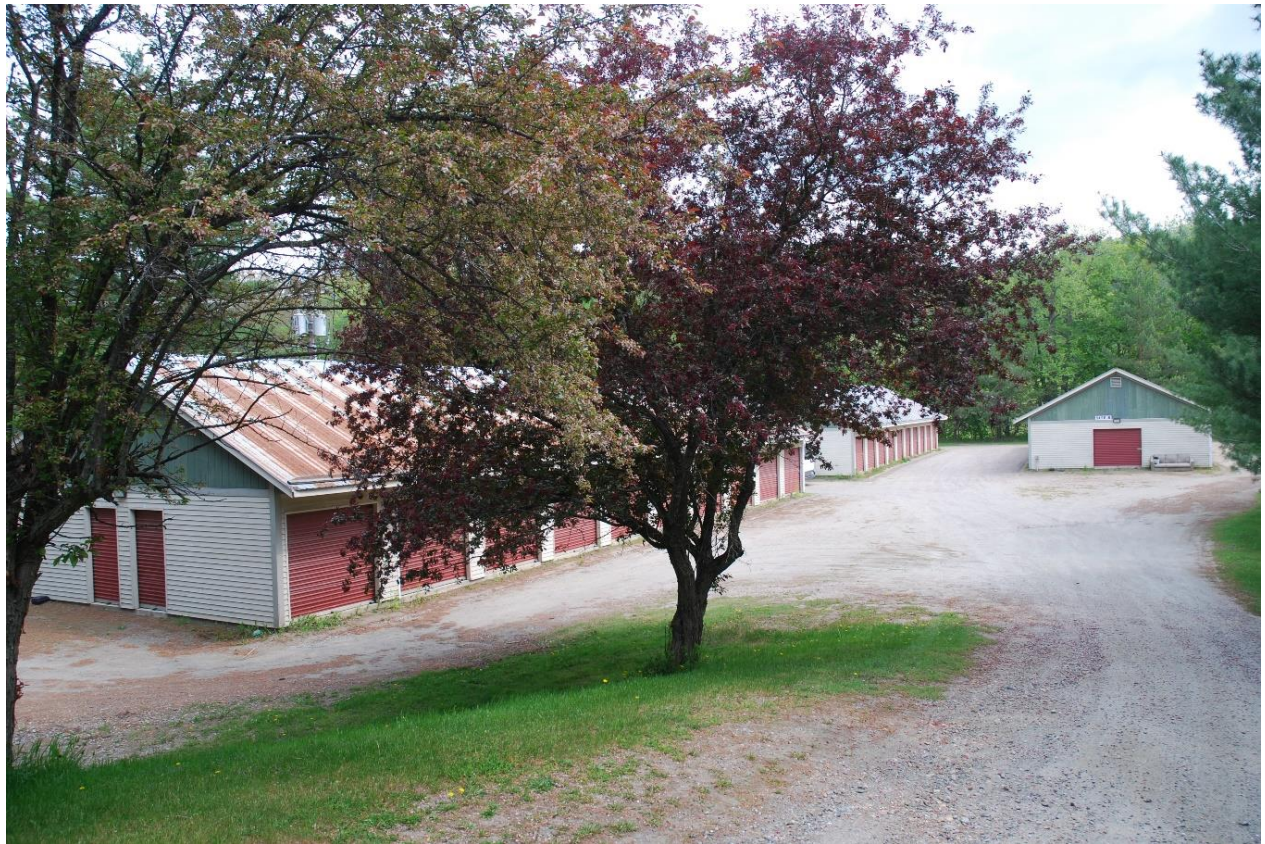
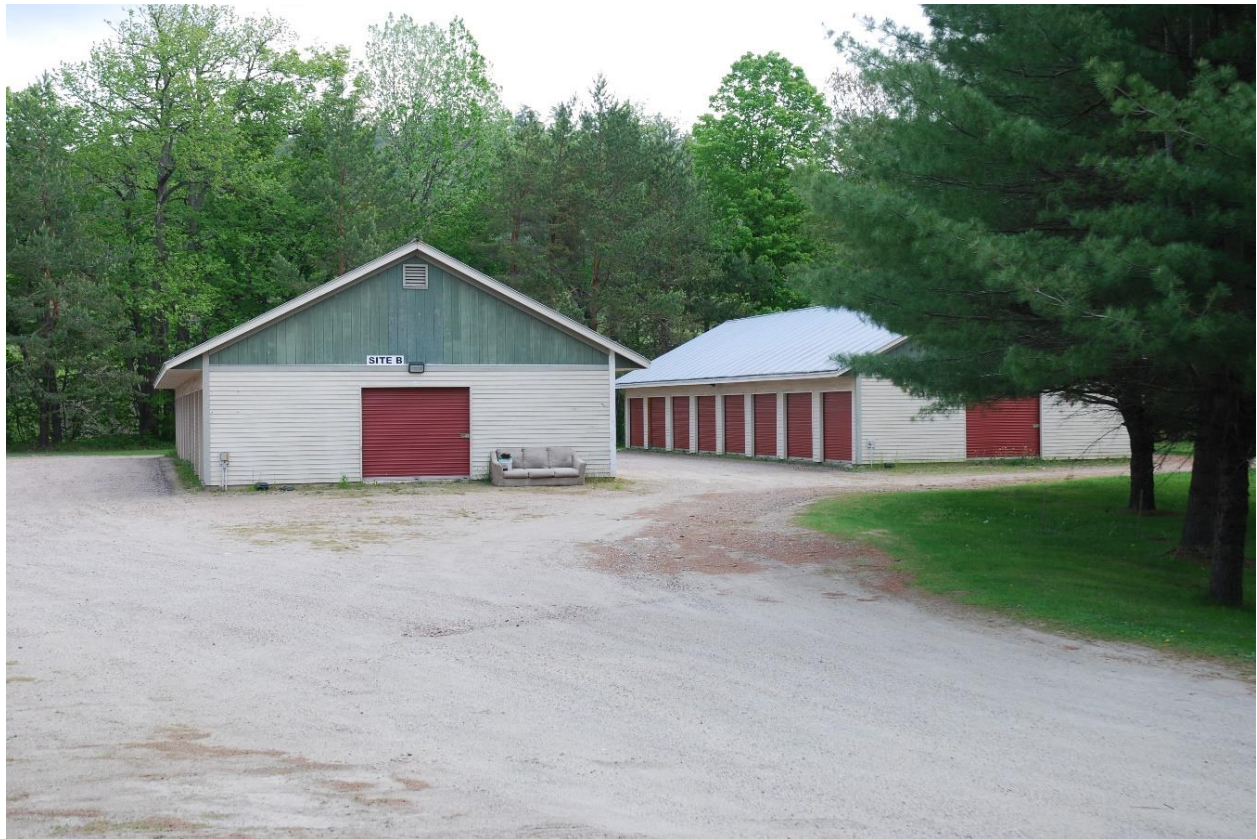
Photo 14. View of structures associated with Resource 5 at 251 Route 2, looking northeast.

Photo 15. View of structures associated with Resource 5 at 251 Route 2, looking east-northeast.

Resource 5 (Photo 14 and Photo 15) is known as Extra Room Storage. It has not been previously surveyed for the potential inclusion in the Vermont State Register or the National Register of Historic Places. Built c.1990, the Extra Room Storage complex consists of four one-story, rectangular storage buildings. They are sheathed in metal siding and have a corrugated metal roof. Steel overhead corrugated metal doors line the eaves' sides, and a combination of overhead or pedestrian doors on the gable ends.

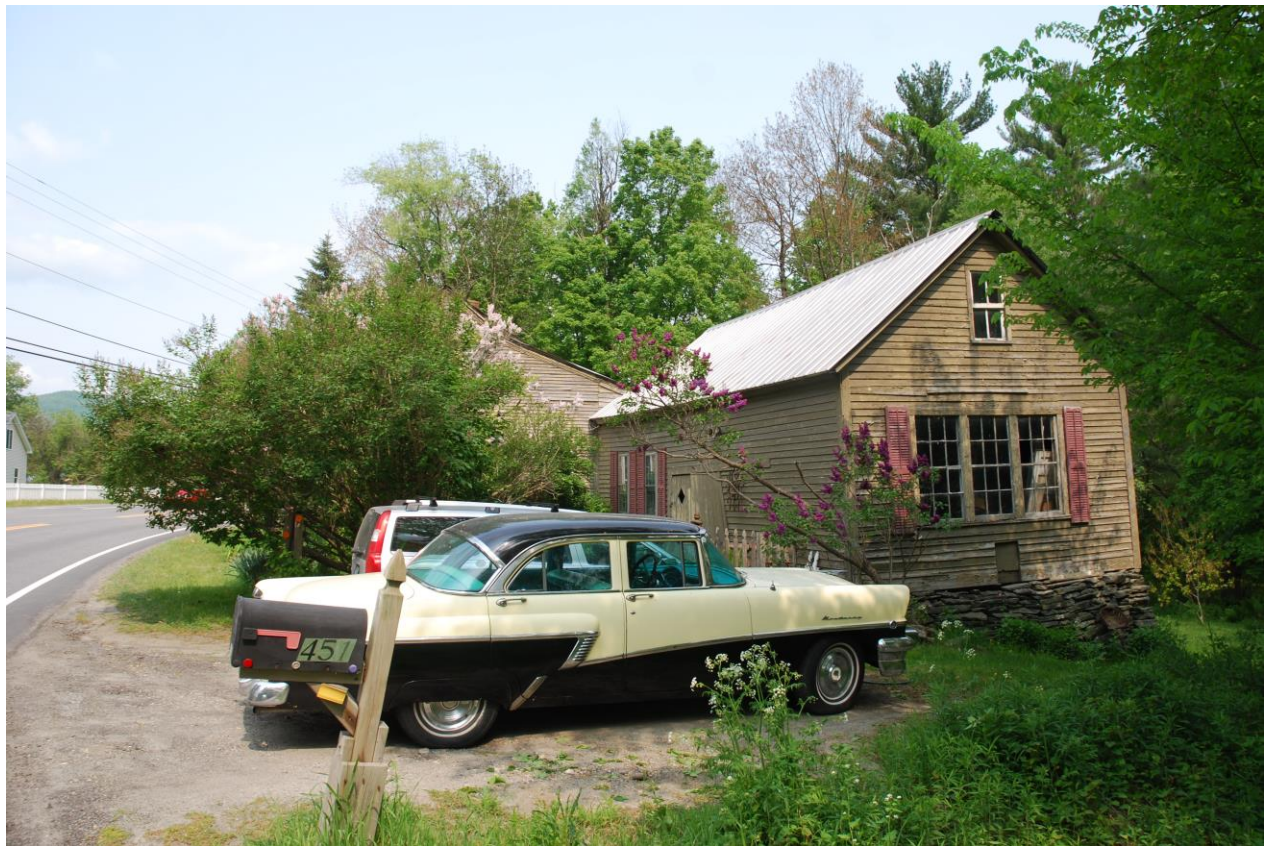
Photo 31. View of Structure 12 at 452 Route 2, looking west-northwest.

Resource 12 (Photo 31 and Photo 32) is the E Taylor House. It has not been previously surveyed for the potential inclusion in the Vermont State Register or the National Register of Historic Places. Built c.1820, this is a one-and-a-half-story, side-gable, wood-frame single-family dwelling. Resting on a stone foundation, it is sheathed with wood clapboards, and it has a corrugated metal roof. Fenestration consists of six-over-six double-hung sash. Projecting from the east elevation is a one-story, gable-roofed wing that connects to a one-and-a-half-story, side-gabled barn.

The E. Taylor house is eligible for inclusion in the National Register of Historic Places under Criterion C. It is one of the oldest remaining houses in North Moretown. Distinctive features include a Cape-style form and an attached shop/barn.
