TA22(11)

May 6, 2024

**MORETOWN  
SHARED USE PATH  
SCOPING STUDY**

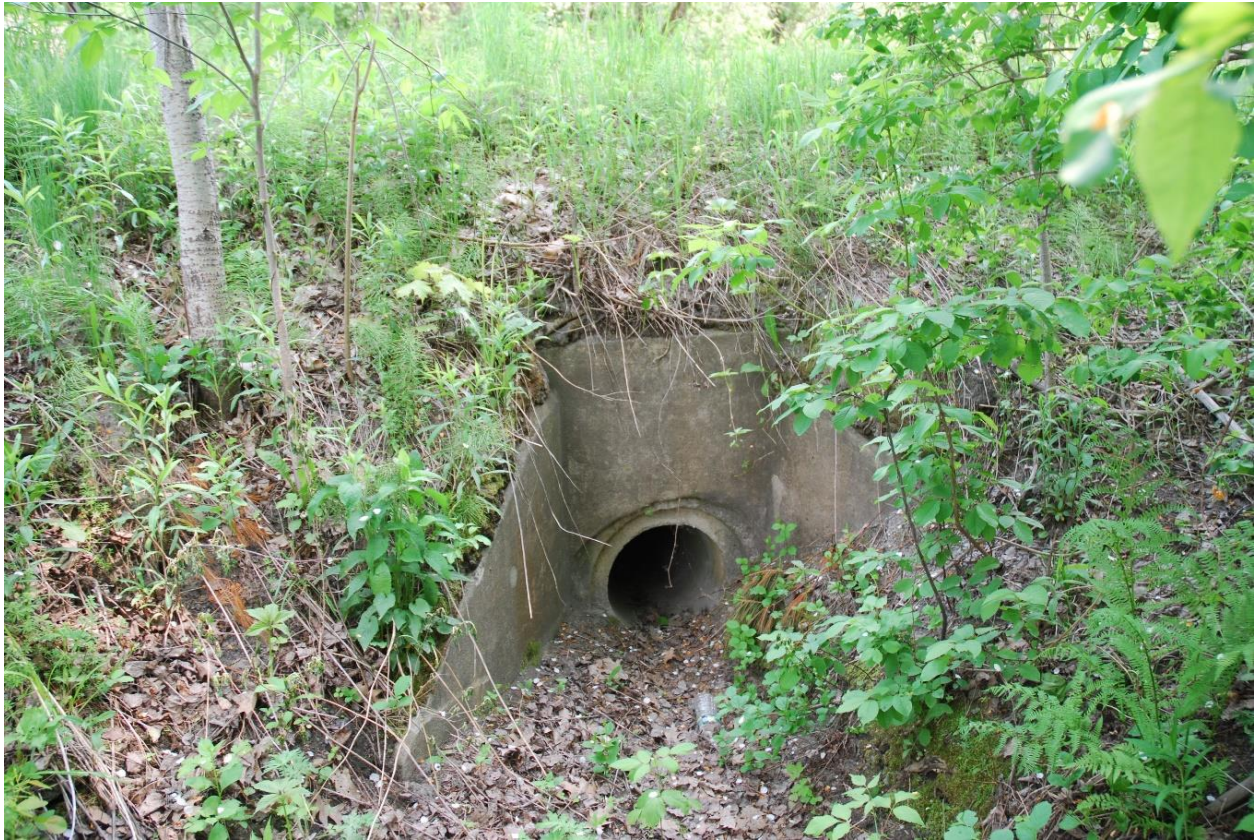
Photo 33. View of Resource 13, looking north-northeast.

Resource 13 (Photo 33 and Photo 34) has not been previously surveyed for the potential inclusion in the Vermont State Register or the National Register of Historic Places. The culvert spanning Route 2 is a c.1920 concrete culvert. The culvert to the south is a c.1970 metal pipe with a stone headwall.

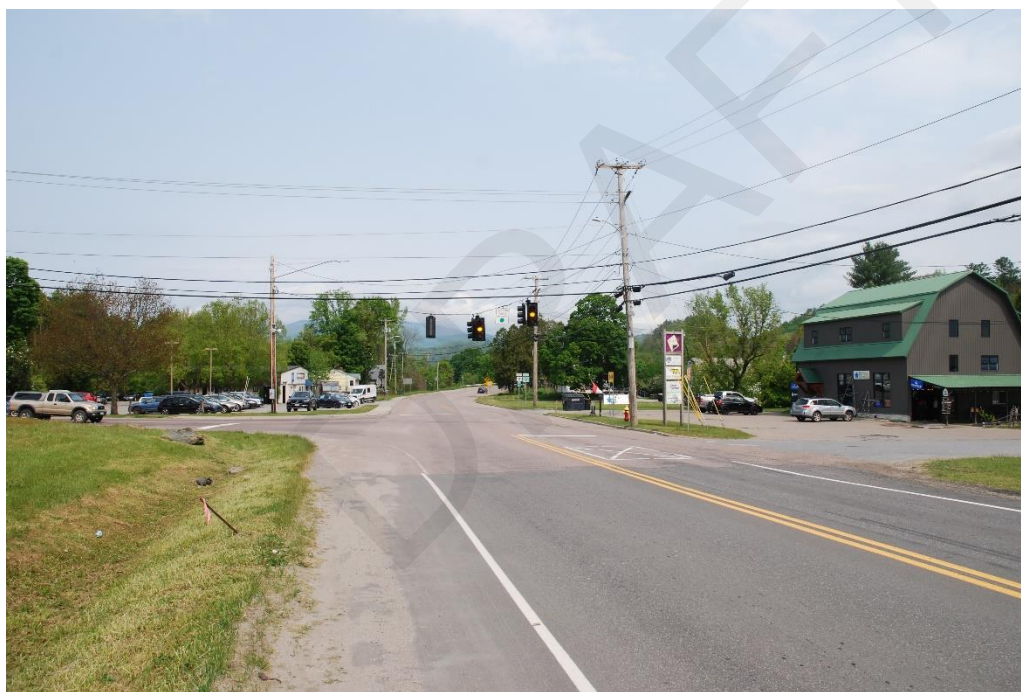
Photo 1. The northern intersection between US Route 2 and Vt Route 100. Note the drainage ditch that runs along the perimeter of the area on the west side of US Route 2 (bottom left of photo). View facing northwest.

| Photo 1. The northern intersection between US Route 2 and Vt Route 100. Note the drainage ditch that runs along the perimeter of the area on the west side of US Route 2 (bottom left of photo). View facing northwest. .... | 4 |

The northern end of the APE is located at the intersection of US Route 2 and Vt Route 100. The APE on the east side of US Route 2 is a parking lot; the northern side of Vt Route 100 is also a parking lot and APE section abutting VT Route 100 on the south is an open field with a drainage ditch perimeter (Photos 1 and 2). The northeast side of US Route 2 in this area steeply slopes down to a paved parking lot area and complex of facility buildings (Photos 3 and 4). On the western side of US Route 2 in this area is a small, wooded area comprised of small saplings and young trees indicating new growth woods (Photo 5). Moving further south along US Route 2 there is a historic cemetery on the east side of the road and modern fenced in housing on the west side (Photo 6).

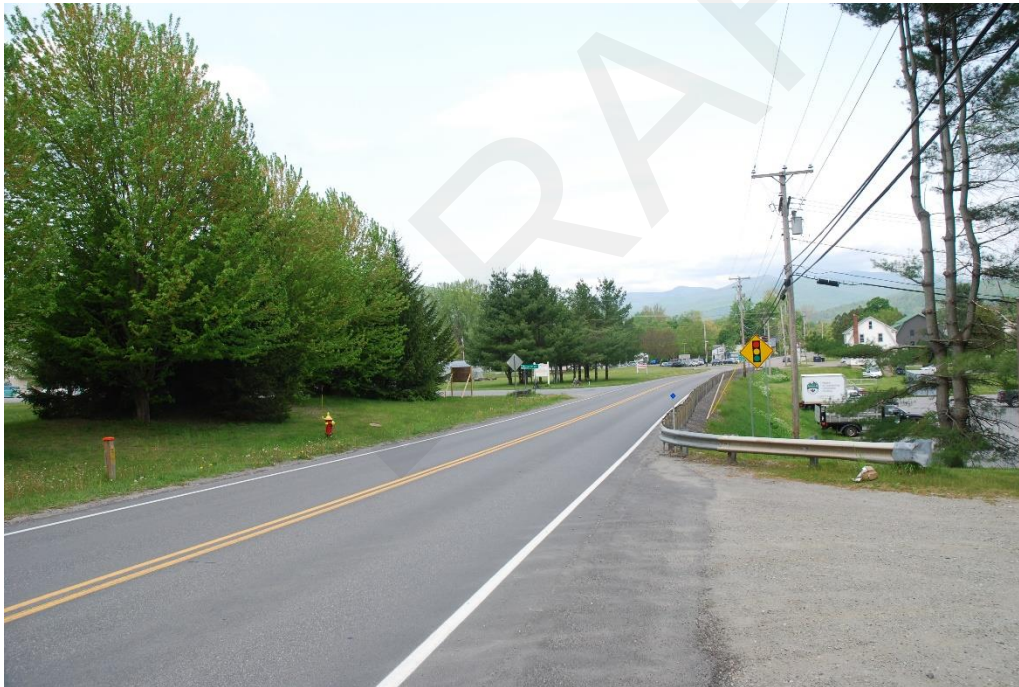
Photo 3. View along US Route 2. Note the sharp slope down on the east shoulder of the road and fire hydrant on the west side indicating buried utilities in that area. View facing northwest.

| Photo 3. View along US Route 2. Note the sharp slope down on the east shoulder of the road and fire hydrant on the west side indicating buried utilities in that area. View facing northwest. .... | 5 |

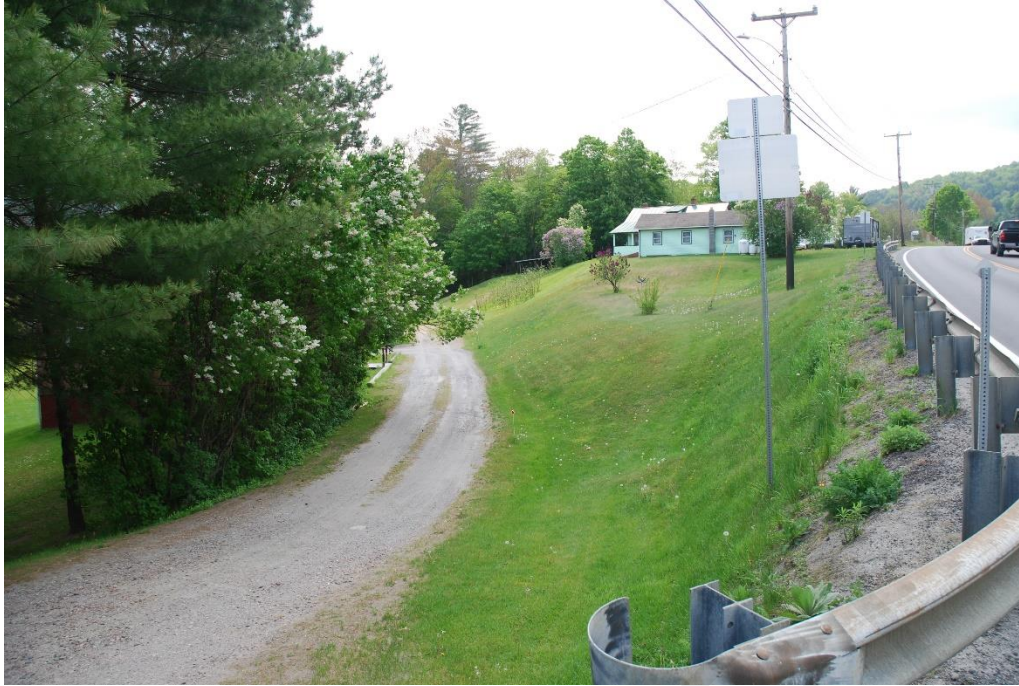
Photo 4. View of the east side of US Route 2. Note the sharp slope down from the highway to the dirt road below. View facing southeast.

| Photo 4. View of the east side of US Route 2. Note the sharp slope down from the highway to the dirt road below. View facing southeast. .... | 6 |

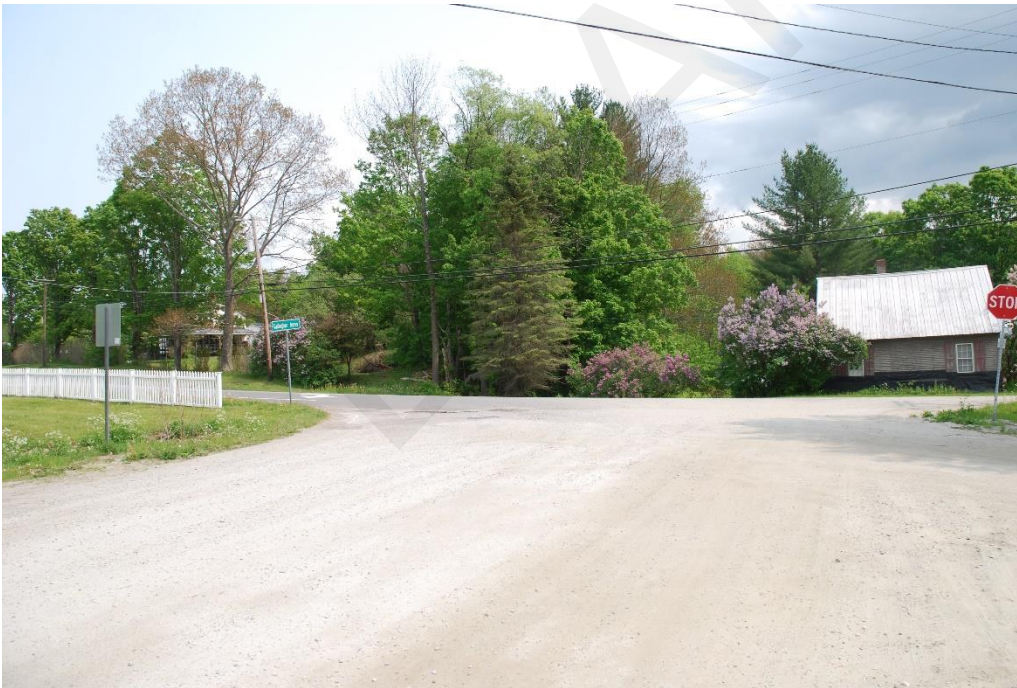
Photo 9. View of the US Route 2 and Gallagher Acres intersection. Note the 19<sup>th</sup>-century house (top right of photo) and decorative bushes that indicate the yard area is below the grade of the road. View facing north-northeast.

Photo 9. View of the US Route 2 and Gallagher Acres intersection. Note the 19<sup>th</sup>-century house (top right of photo) and decorative bushes that indicate the yard area is below the grade of the road. View facing north-northeast..... 8

At the southern end of the APE US Route 2 intersects with Gallagher Acres. A hedgerow separates US Route 2 from a residential road that runs parallel to the highway (Photo 8). East of this intersection is the 19<sup>th</sup> century house identified on the Walling 1858 map as the E. Taylor House (Walling 1858). This historic building is in close proximity to the edge of the road and the yard area lies below the grade of the road (Photo 9).
