ENERGY AUDIT REPORT – Moretown Library

Date: 7/19/10

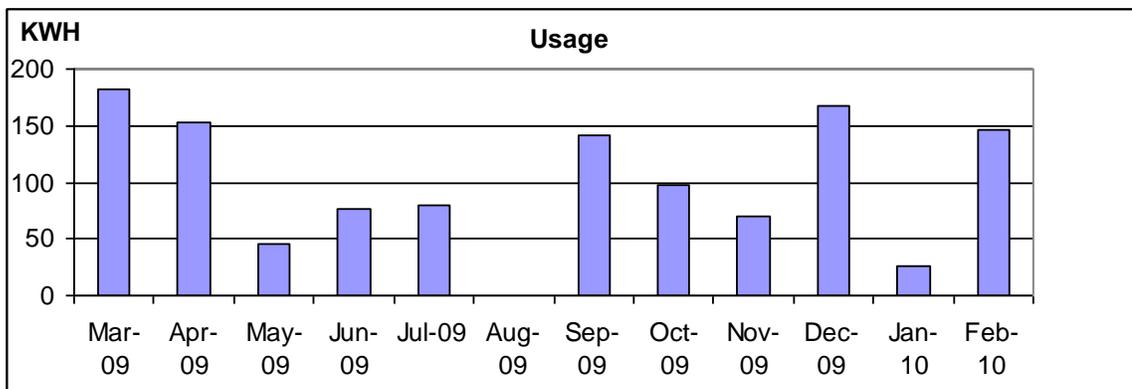
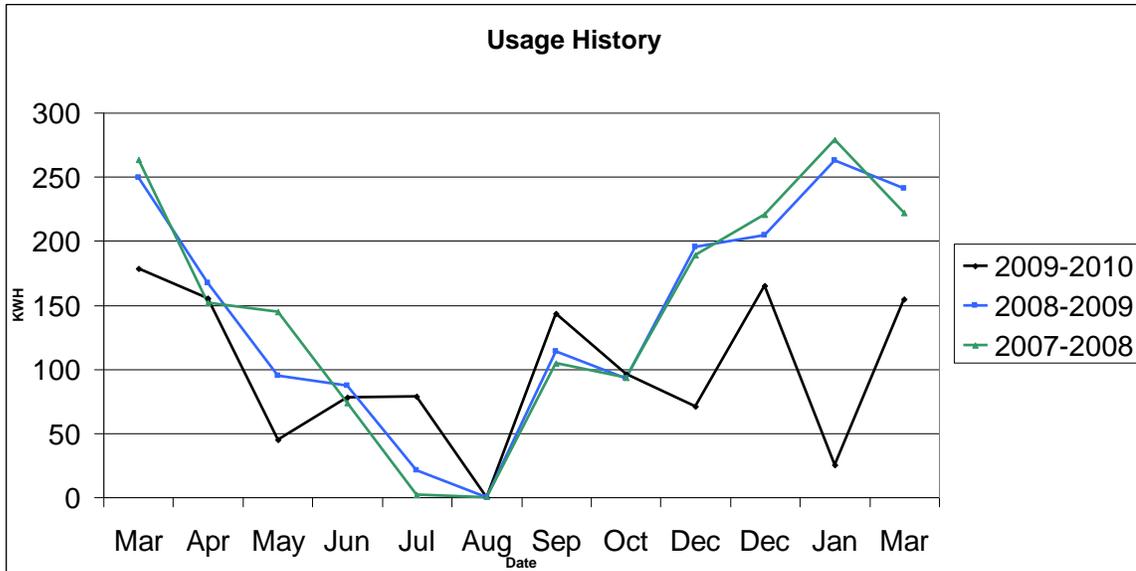
Average base load is 35 kWh per month. Usage is higher in the winter which is most likely due to the shorter daylight hours and the Rinnai fan operating. Refer to the charts below:

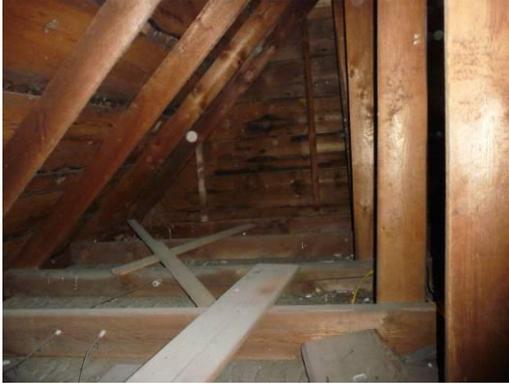
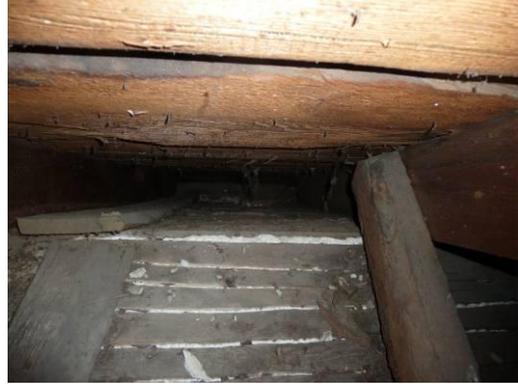
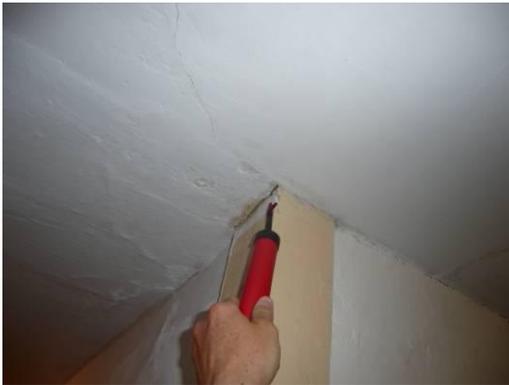
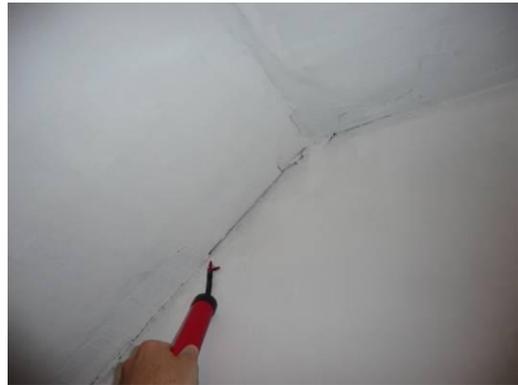
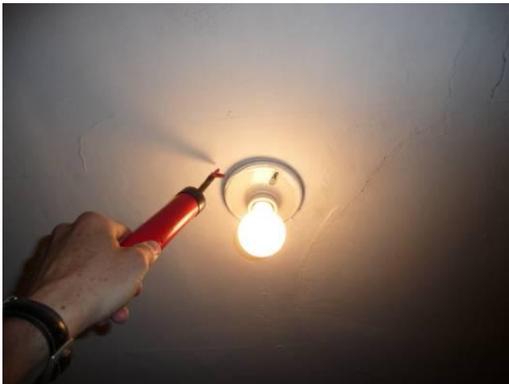
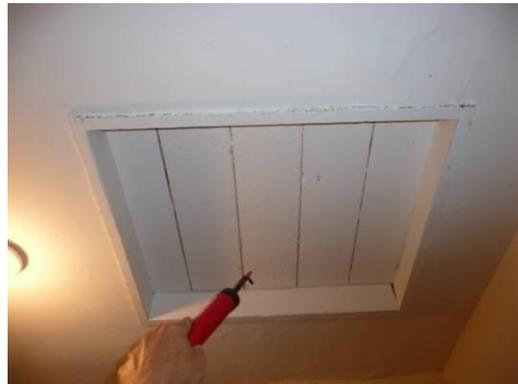
The attic floor and ceiling slants are not insulated or air sealed. Heated air can move through penetrations and openings in the ceiling plane and leak into the attic. Air sealing and insulating the attic and ceiling slants is a top priority.

1. *Attic: Air seal all wall plates, wire chases, light openings, junction boxes, chimney shafts, and miscellaneous openings. Install 16" of cellulose. Upgrade to R-60. +/-370 square feet. Budget \$1,700. Save +/- 14% of heat costs.

2. *Slanted Ceilings: While insulating the attic, install dense pack cellulose in the slanted ceiling cavities. Upgrade to R-26. +/-275 square feet. Budget \$700. Save +/- 9% of heat costs.

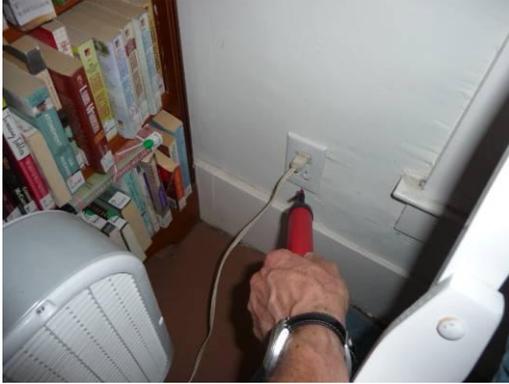
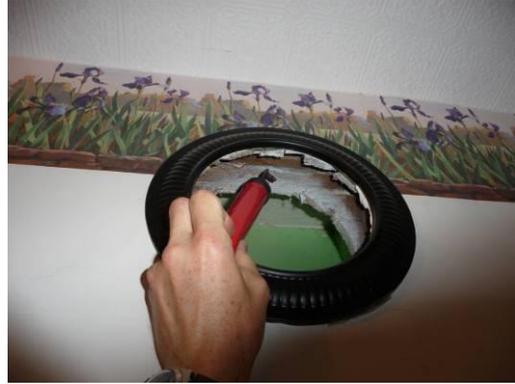
Air can move through penetrations in the un-insulated exterior walls and the interior walls and leak into the attic. The top plates of all interior and exterior walls should be air sealed from the attic to reduce the loss of heated air.

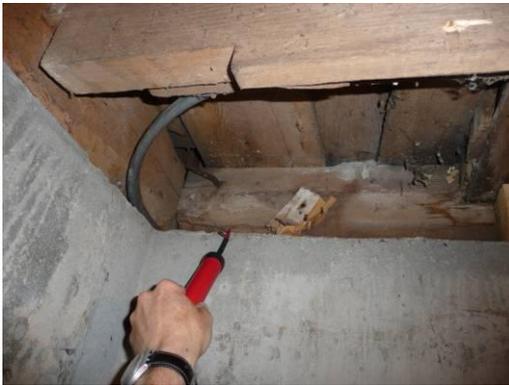
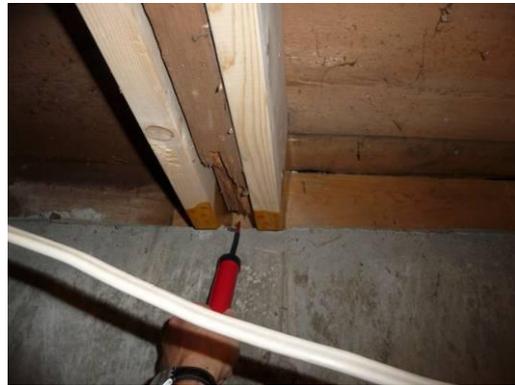
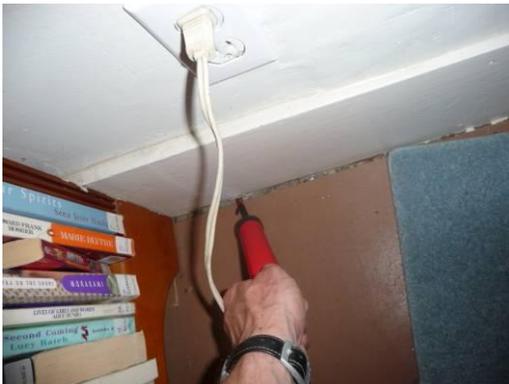
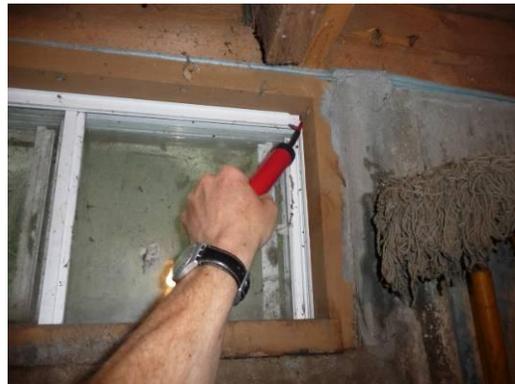
As heated air leaks into the attic, cold air is drawn in through the basement to replace it. The junction of the timber sill and concrete foundation is a source of air leakage. This air can leak into the basement and through the first floor baseboard. The basement windows also leaked air. The timber sill and basement window perimeter need to be air sealed.

3. *Basement: Apply 2" of closed-cell spray foam to the first floor timber sill, short wood framed wall at rear, and down 3' around the interior side of the perimeter foundation wall. Upgrade to R-13. +/-410 square feet. Budget \$1,100. Save +/- 13% of heat costs. Install fire protection coating over the exposed foam. Budget \$650.

- b. Air seal the two other chimney thimble plugs.
 - c. Caulk around the perimeter of the basement windows.
 - d. Air seal the shim space of the windows.

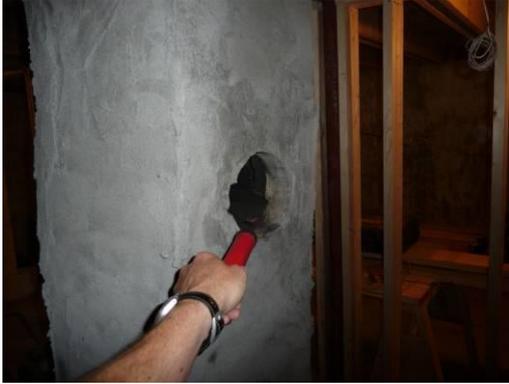
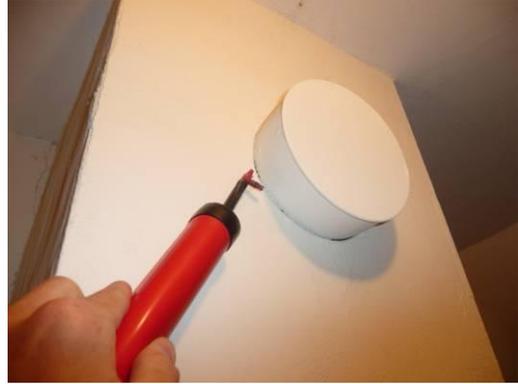
The open chimney thimble in the basement is a major source of air leakage. This should be plugged and air sealed. The thimble on the second floor is plugged, but it needs to be air sealed.

5. *Air Sealing: Use caulk, foam sealant, or other air sealing methods to address the following:
 - a. Plug and air seal the open chimney thimble in the basement.

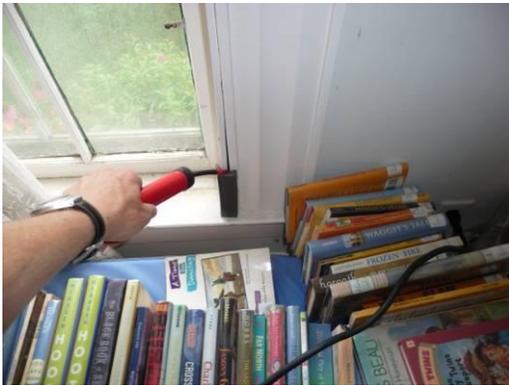
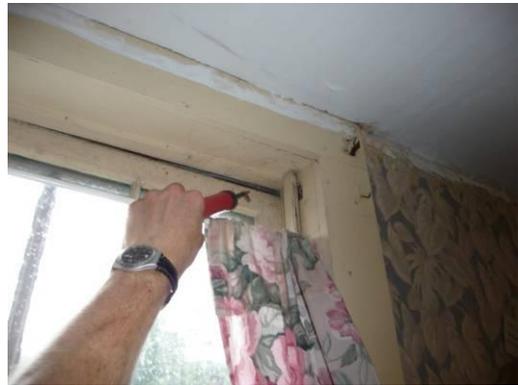
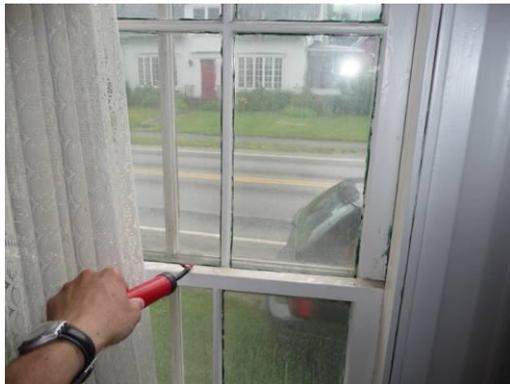
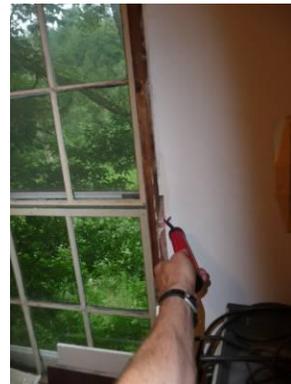
Windows are a source of air leakage, however, addressing the heat loss in the attic and basement areas is a much higher priority. Windows should be adjusted so they close tight in the winter. The exterior storm windows do help reduce heat loss. The interior window trim can be removed and the shim space air sealed with low expansion foam sealant. In the future, the windows can be replaced.

- e. Budget \$480 for eight man-hours of air sealing labor. Save +/- 2% of heat costs.
6. Windows: In the future, replace the windows with warm edge technology tri-pane units. Energy efficient windows cost \$400-\$1,000 each depending on

level of efficiency. Air seal the shim space with low expansion foam sealant during installation. Save +/- 7% of heat costs.
